WATERSHED FISHERIES REPORT AND EARLY ACTIONS

A Study of the Upper Salinas River and Tributaries

Report to the California Department of Fish and Game

Upper Salinas-Las Tablas Resource Conservation District

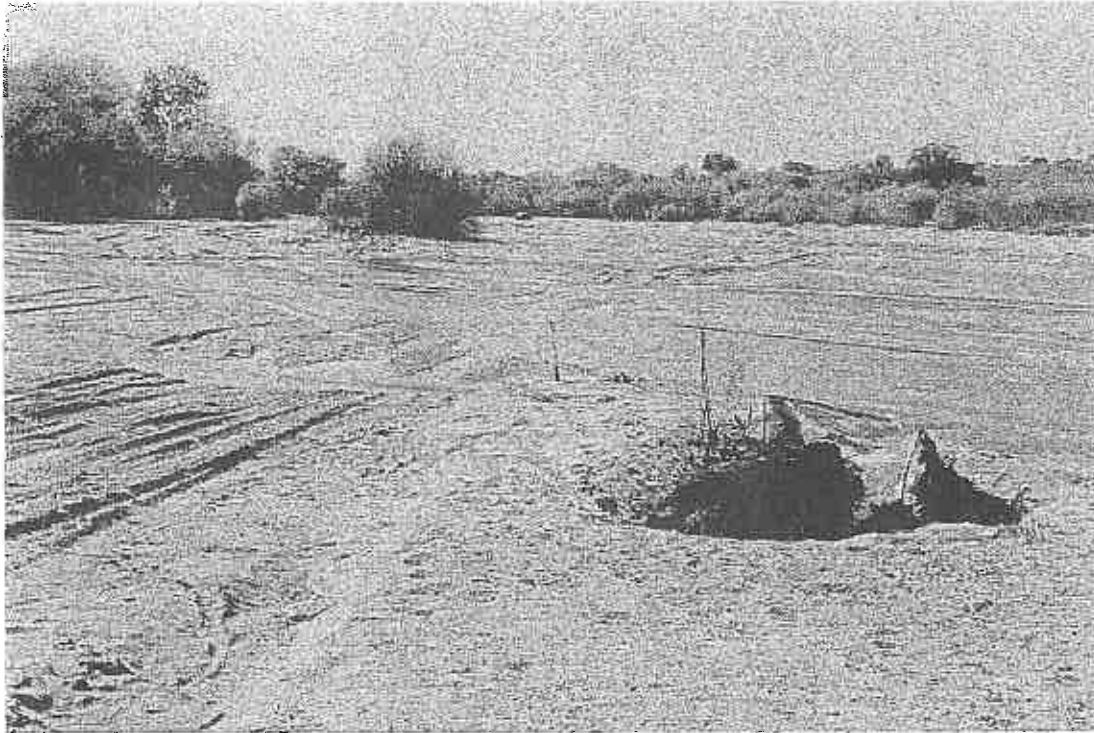
Offroad vehicles in the Salinas River have destroyed habitat and polluted the water

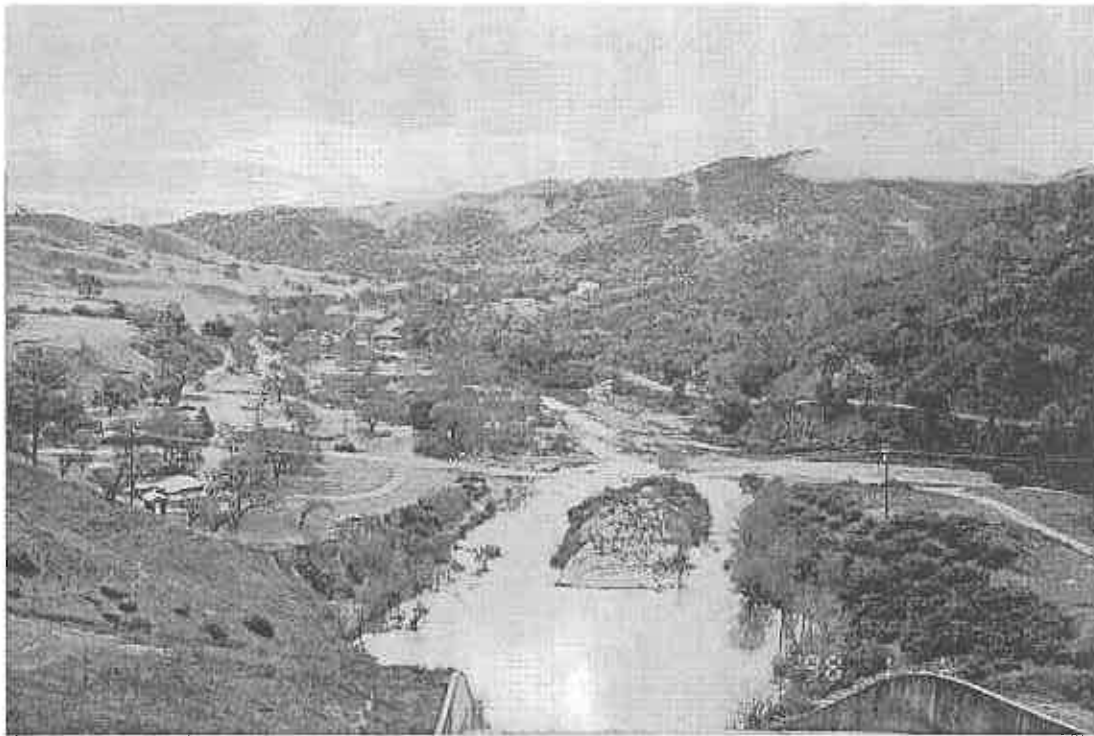
**Nacimiento River looking downstream from the dam.
Steelhead no longer have access to the Nacimiento River west of the dam.**

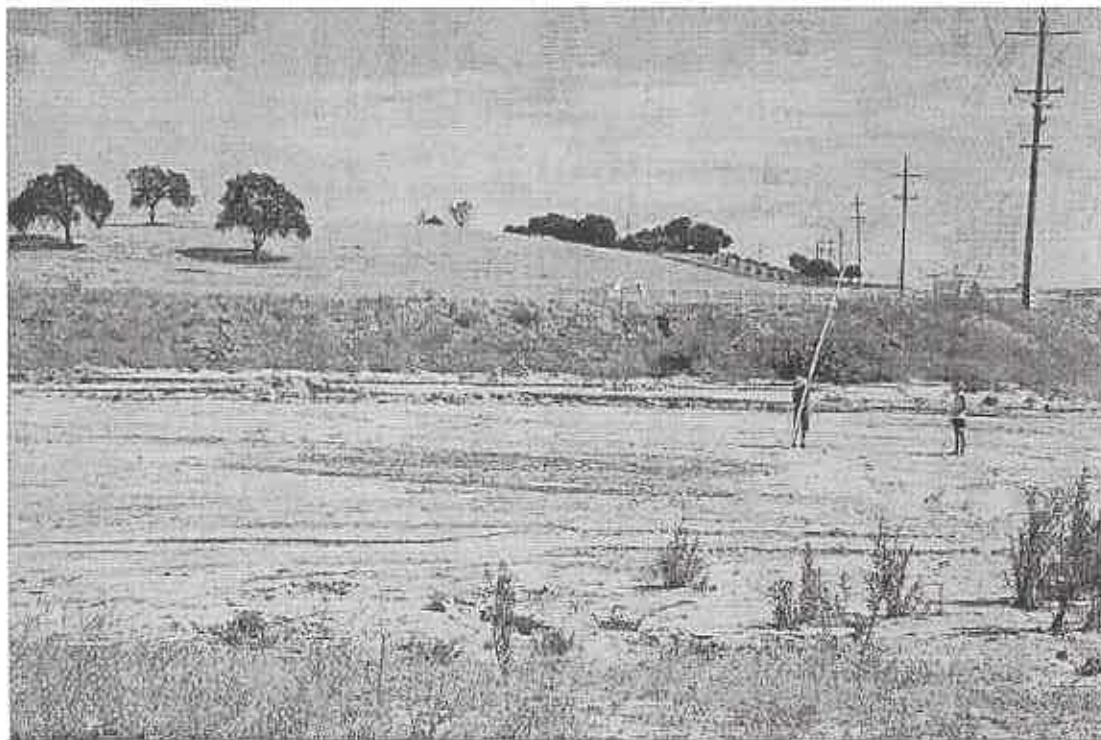
**The Estrella River one mile east of the confluence with the Salinas River.
Riparian vegetation along the Estrella has disappeared.**

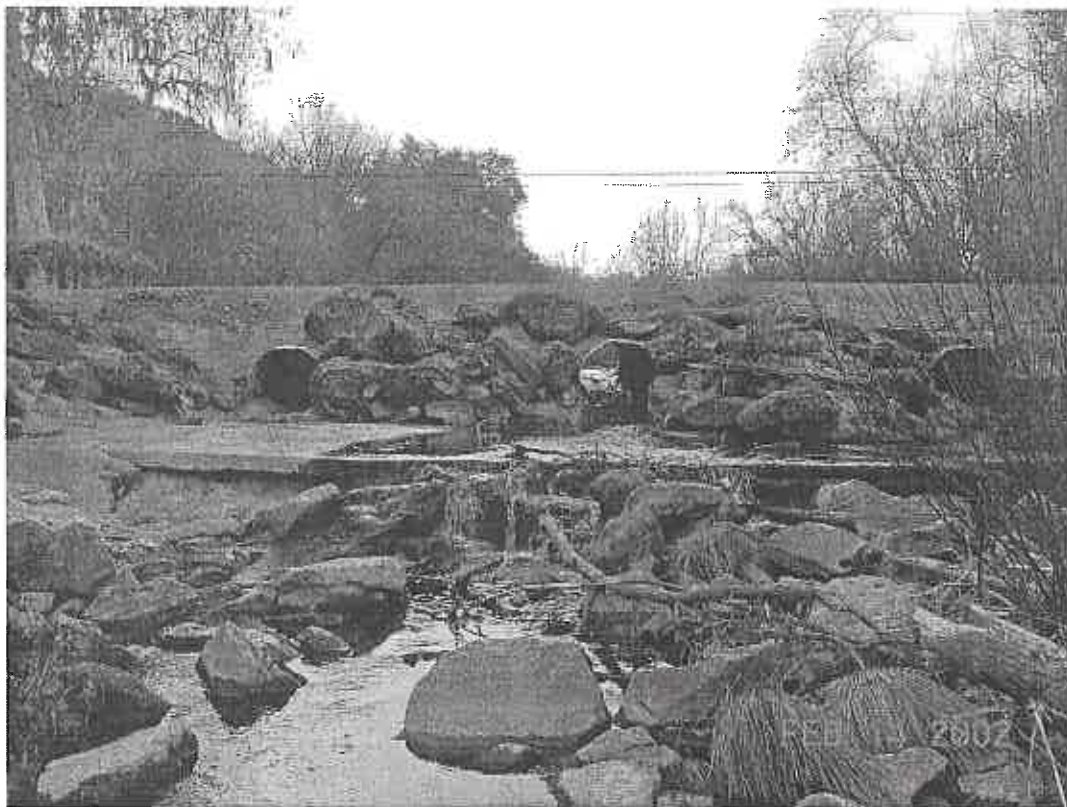
Fish Barrier on Paso Robles Creek upstream confluence with Santa Rita Creek

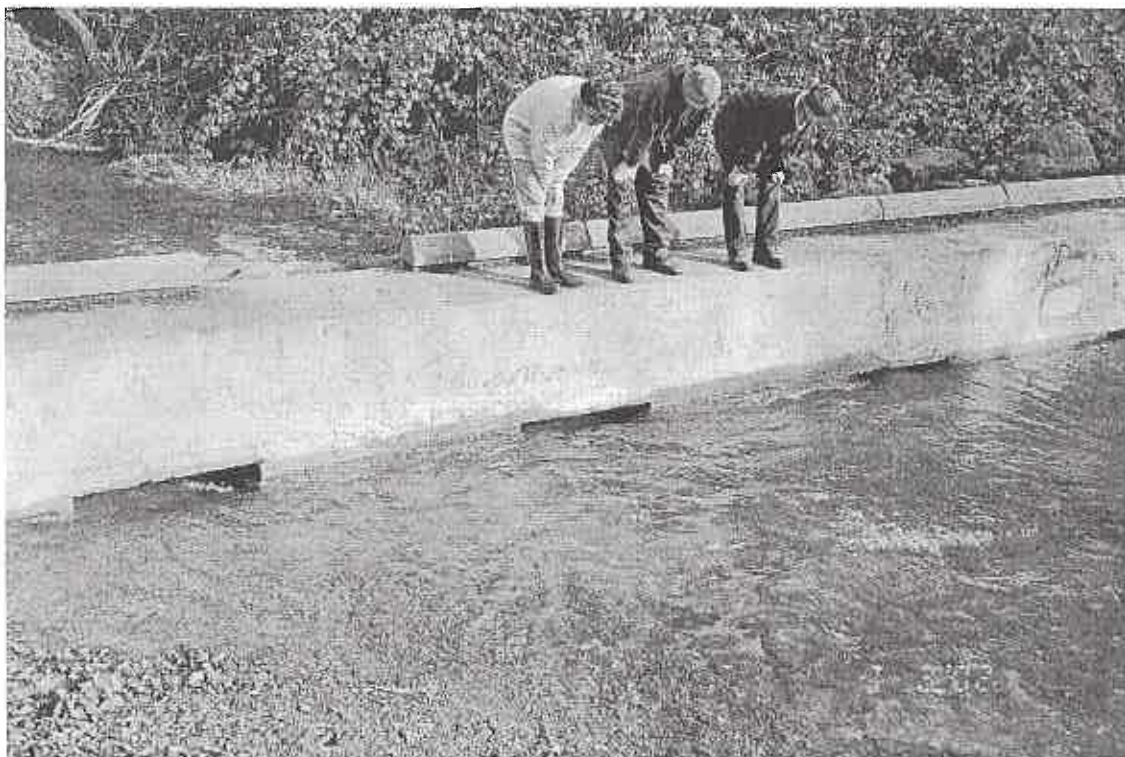
Fish Barrier on Atascadero Creek at Curbaril Road sewer line crossing

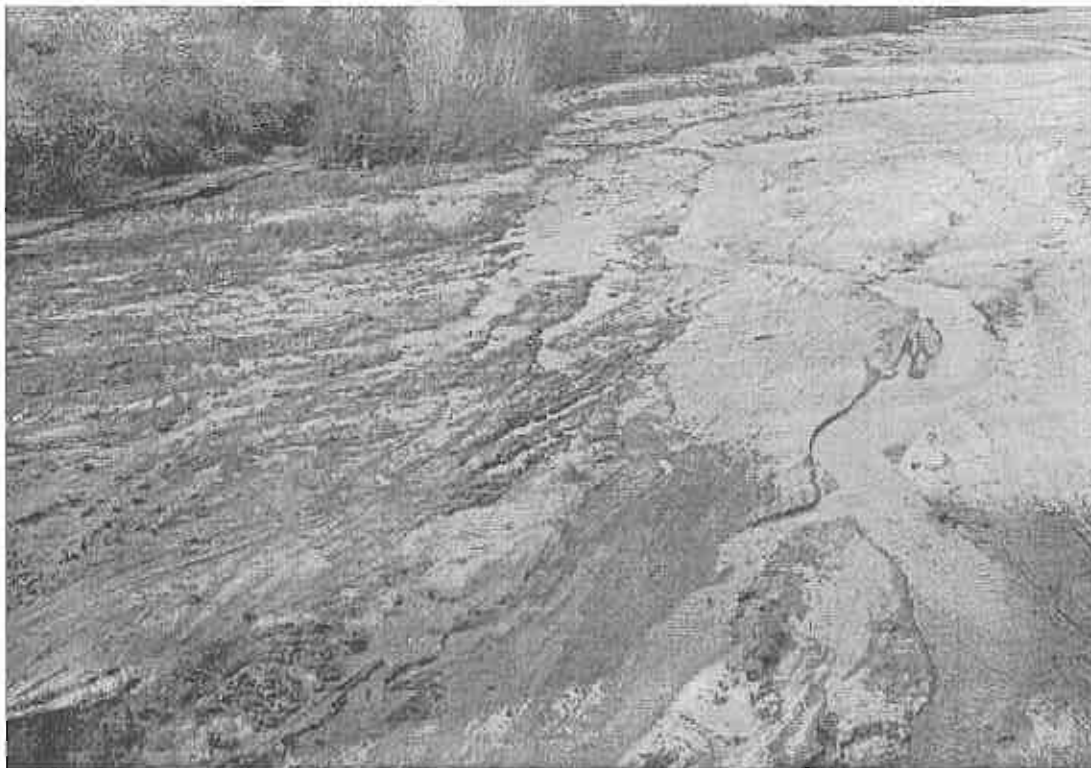
Vehicle destruction of vegetation and alteration of natural channel flow in the Salinas River near Templeton

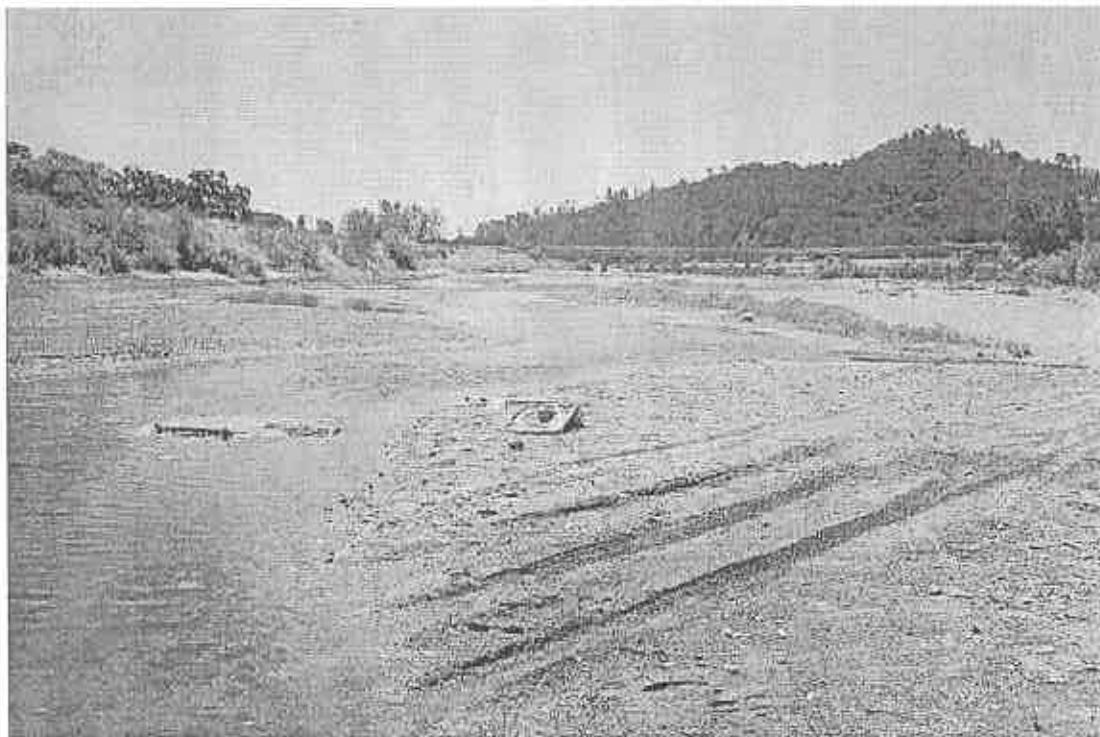
Trash and damage from OHV use in Salinas River at Atascadero Creek

Vehicle use in both Atascadero Creek and the Salinas River is quite evident at this reach. Tire tracks and vehicle debris is prevalent, even during stream flow. Frequent OHV recreational use of the stream and river has been observed. Compaction of the channel sands and gravels as well as the destruction of young riparian vegetation is an obvious result.

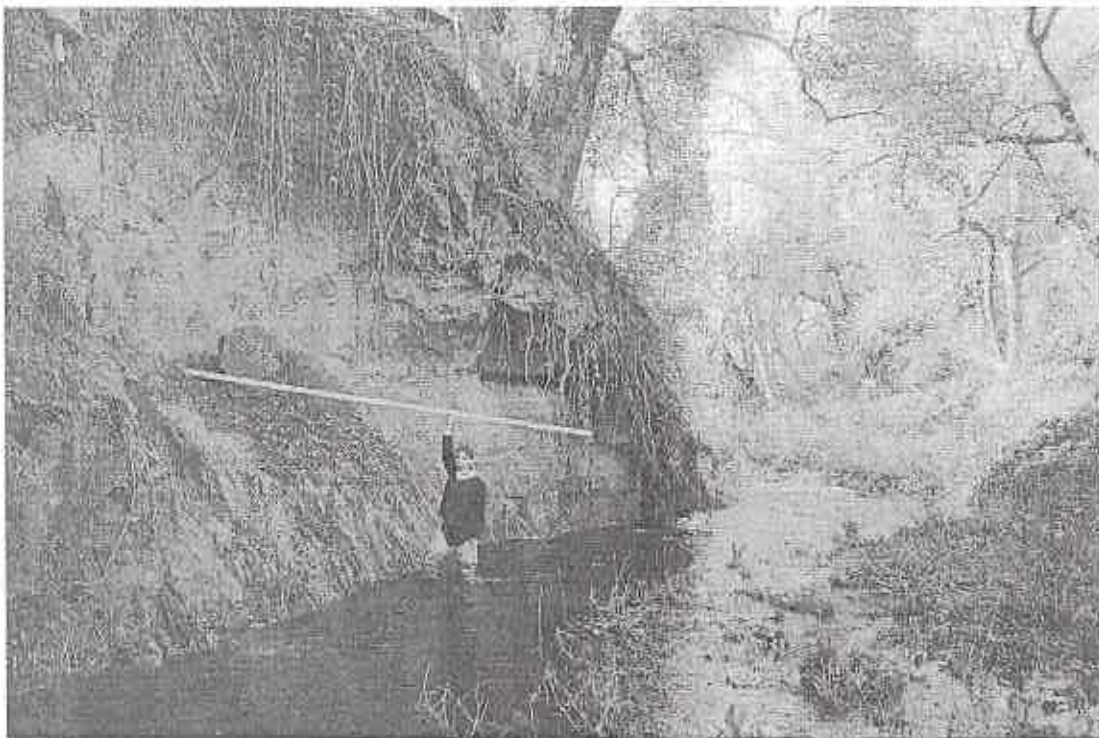
**In-Channel Erosion caused by loss of vegetation and channel entrenchment.
Location: Atascadero Creek 350 feet upstream of West Mall bridge.**

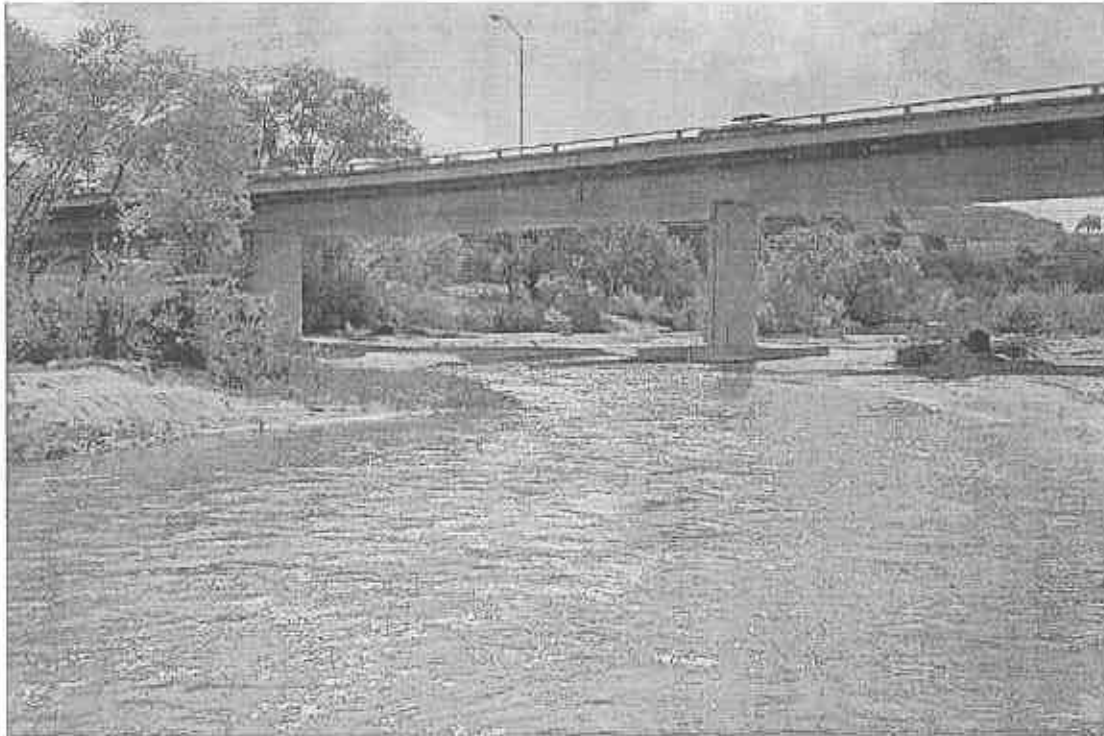
The bed is comprised mostly of sand, with a small proportion of gravels and cobbles. The Salinas River at this location is an unstable F-5 type channel.

Salinas River at 13th Street Bridge, Paso Robles

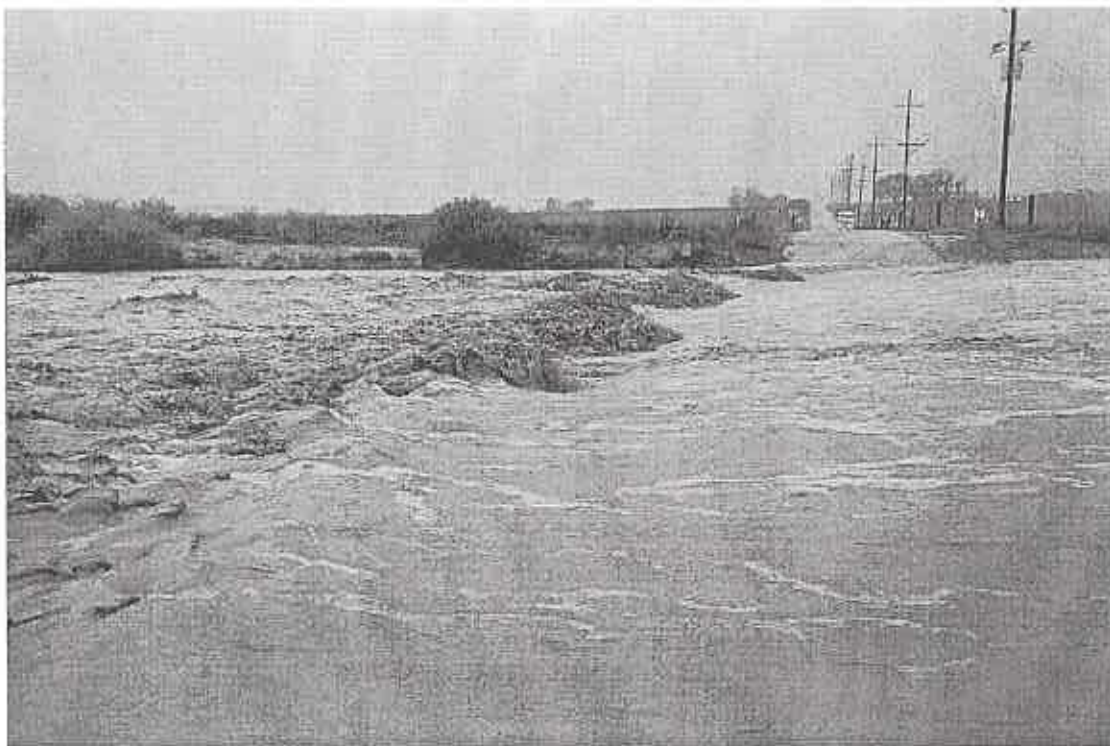
The Estrella River during a storm at the North River Road crossing. The Estrella carries significant amounts of suspended sediments during storm flows.

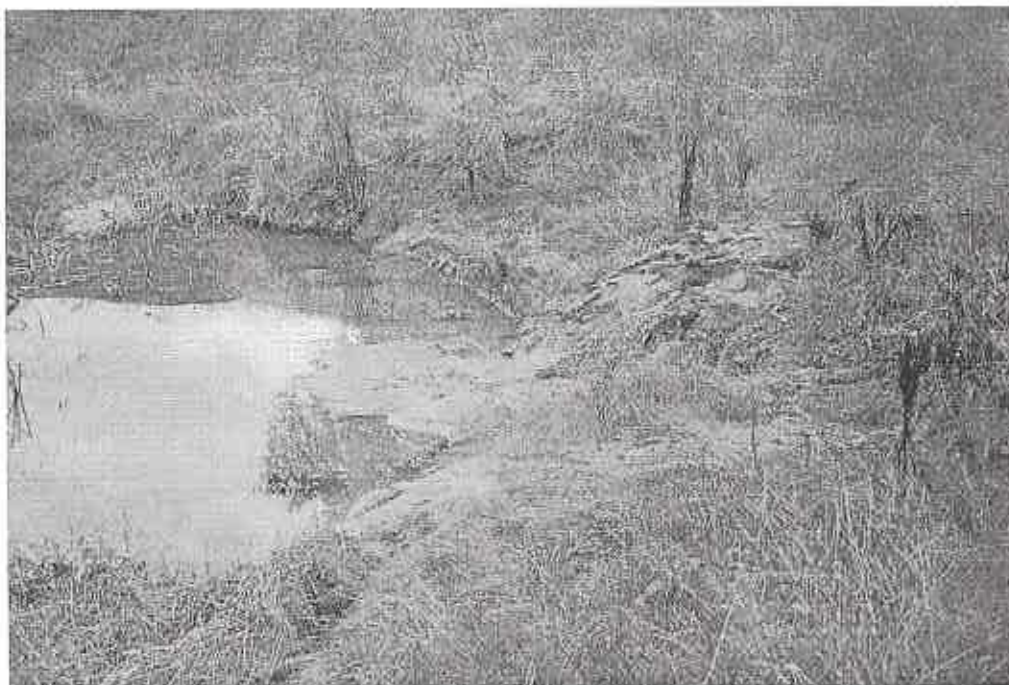
**Creek clogged with sediment from soil erosion
caused by road in photo above**

Prevent erosion from roads that result in sediment in streams

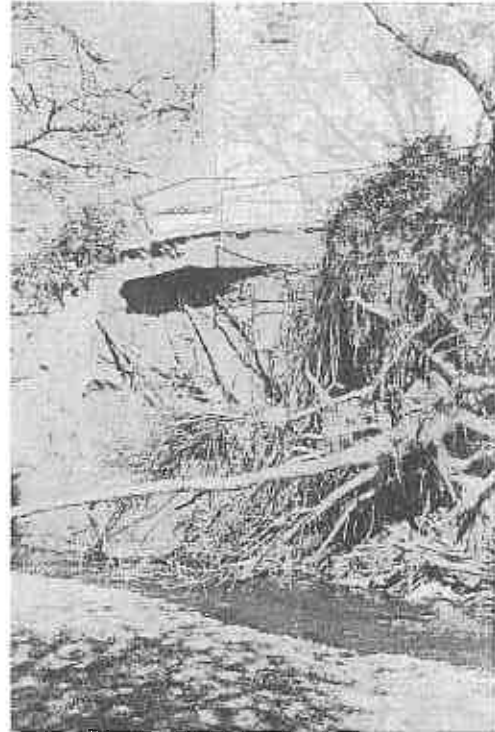
Buildings constructed close to creeks create unsafe conditions

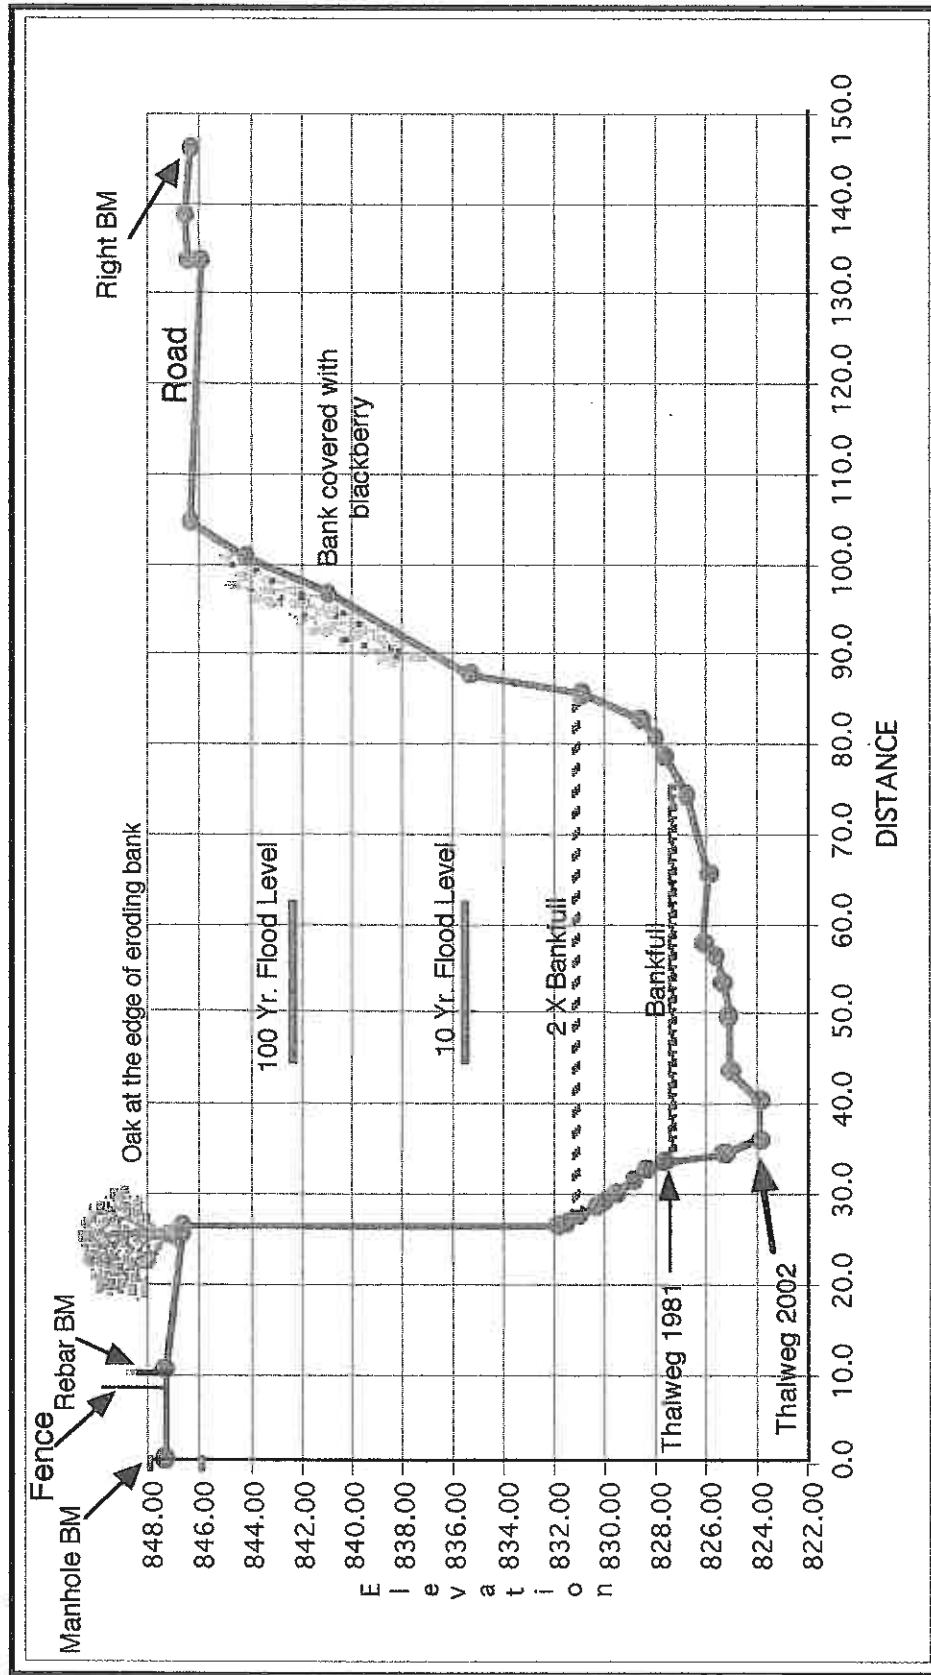
Distance 5,300 ft. from
Salinas R. confluence

At the 5,300 cross-section, the entrenchment ratio is 1.15 to 1. This area of the channel is extremely entrenched and unstable. The entrenched channel causes high stream velocities. The Army Corps estimated velocities of 10.6 feet per second during a 100-year storm and flows of 6,625 cubic feet per second. The left channel bank has eroded horizontally 3.1 feet during the past 12 months. A very large oak tree is being threatened; its roots have been undermined by the erosion. A pool across from the oak tree has filled with sediment during the last year. If the bank is not stabilized soon, the weight of the oak tree will overwhelm the strength of the vertical bank and the tree will collapse into the channel, taking with it an estimated 30 feet of terrace soil.

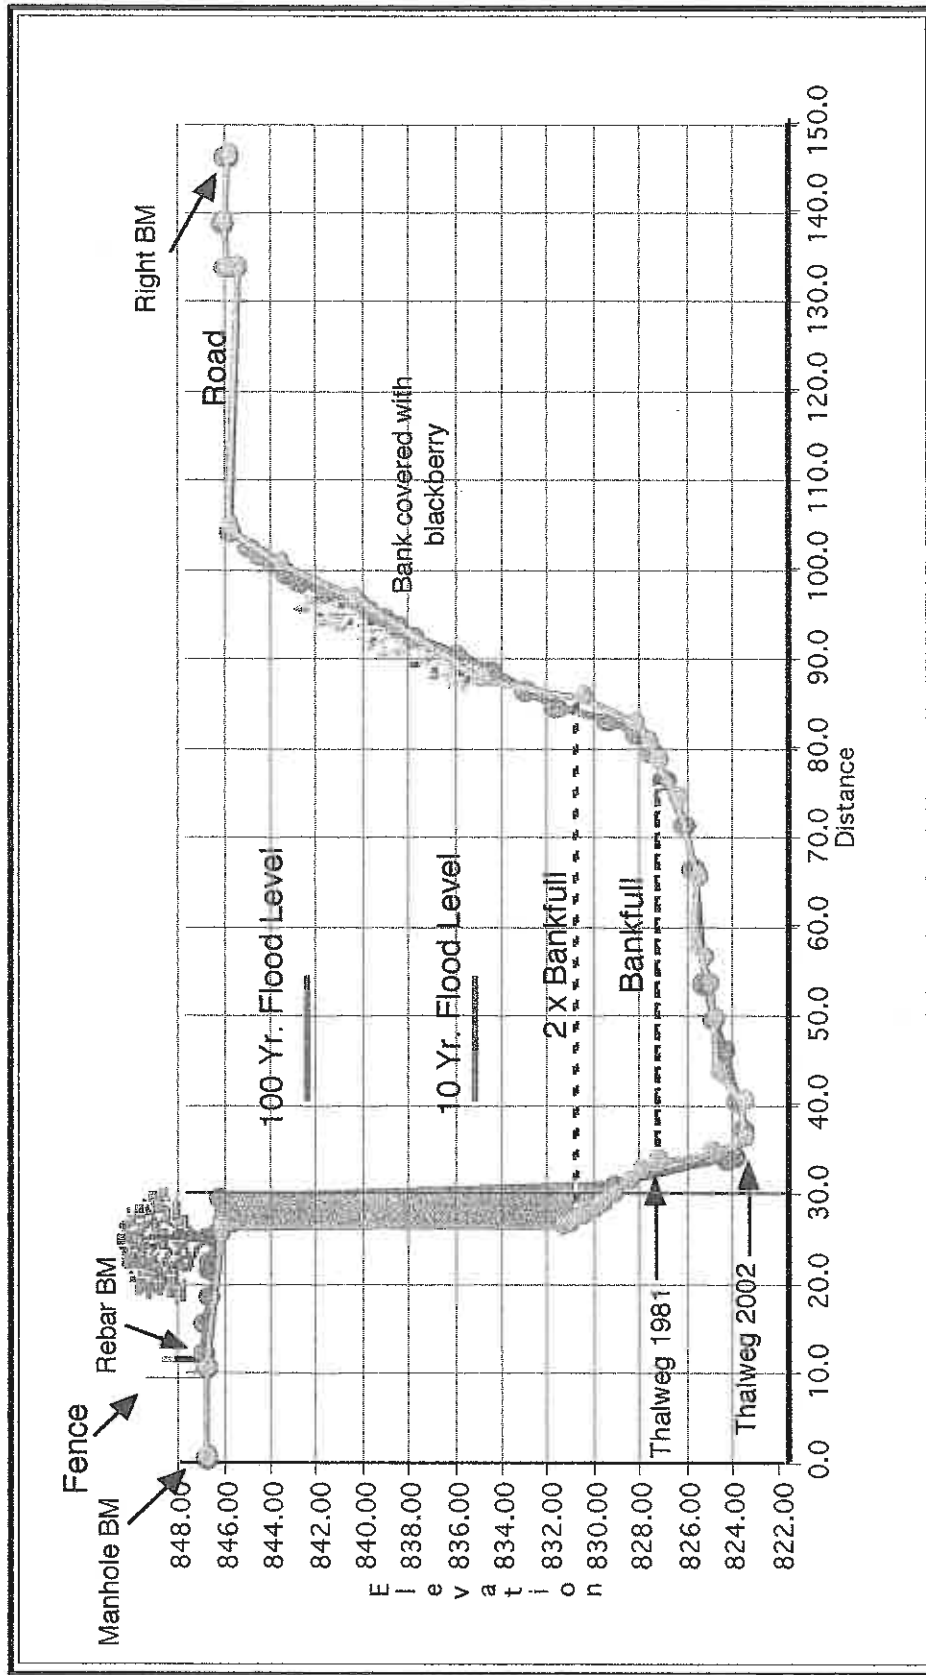
Eroded Soil from
2/01 to 1/02
Feb 7, 2001
Jan 3, 2002
