Santa Rosa Creek Watershed Conservation Plan

Prepared for
California Coastal Conservancy
by
The Land Conservancy of San Luis Obispo County

August 2010

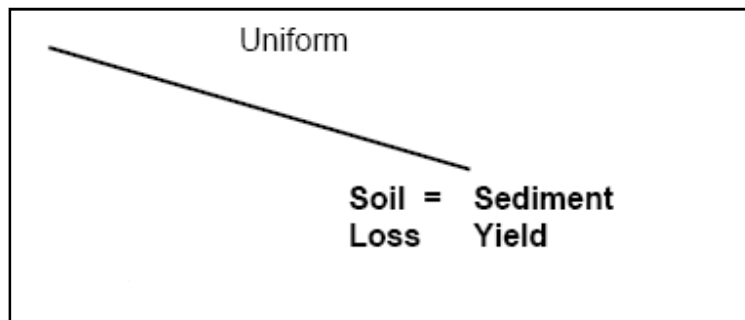
Figure 15. Sediment yield of a uniform slope in RUSLE2 (Forester, 2004).

In the erosion study conducted for the Conservation Plan, a uniform slope was used to describe each site. Uniform slopes generalize the overland flow path as a straight line from the top of the site, to the bottom. This creates a condition where detached sediment would not be deposited on site. In this case, sediment production equals sediment yield. Figure 15 shows the relationship between soil loss and sediment yield of a uniform slope, as calculated in RUSLE2.

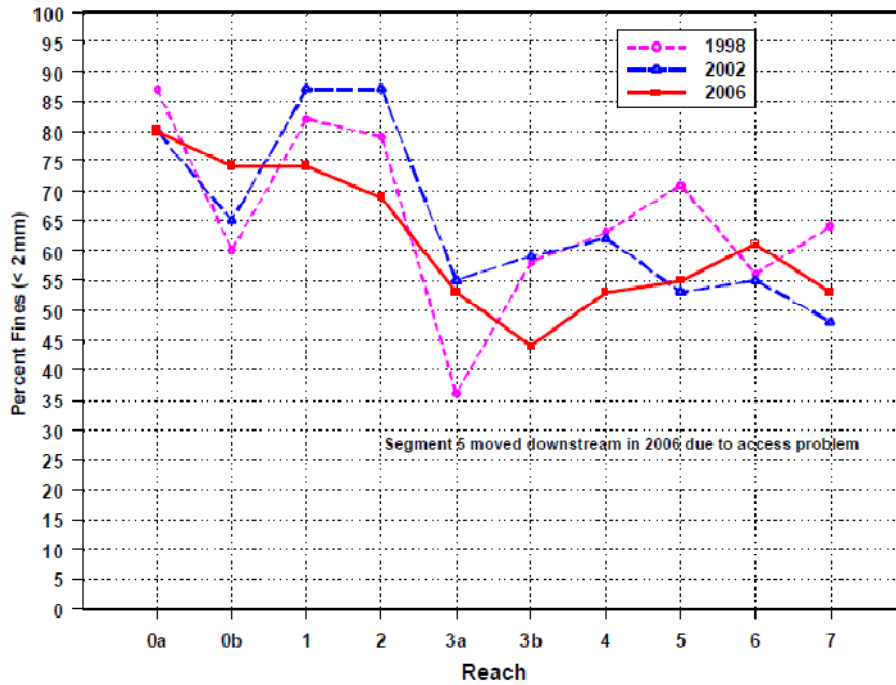
Figure 28. Percent fines in pools in reaches of Santa Rosa Creek at four-year intervals, from 1998-2006 (Appendix L, Fig. 19).
