# Santa Rosa Creek Watershed Management Plan

February 2012

California Department of Fish and Game

Stillwater Sciences, Central Coast Salmon Enhancement, and Greenspace – The Cambria Land Trust. 2012. Santa Rosa Creek watershed management plan. Prepared for the California Department of Fish and Game, under a grant for the Fisheries Restoration Grant Program (P0740401).

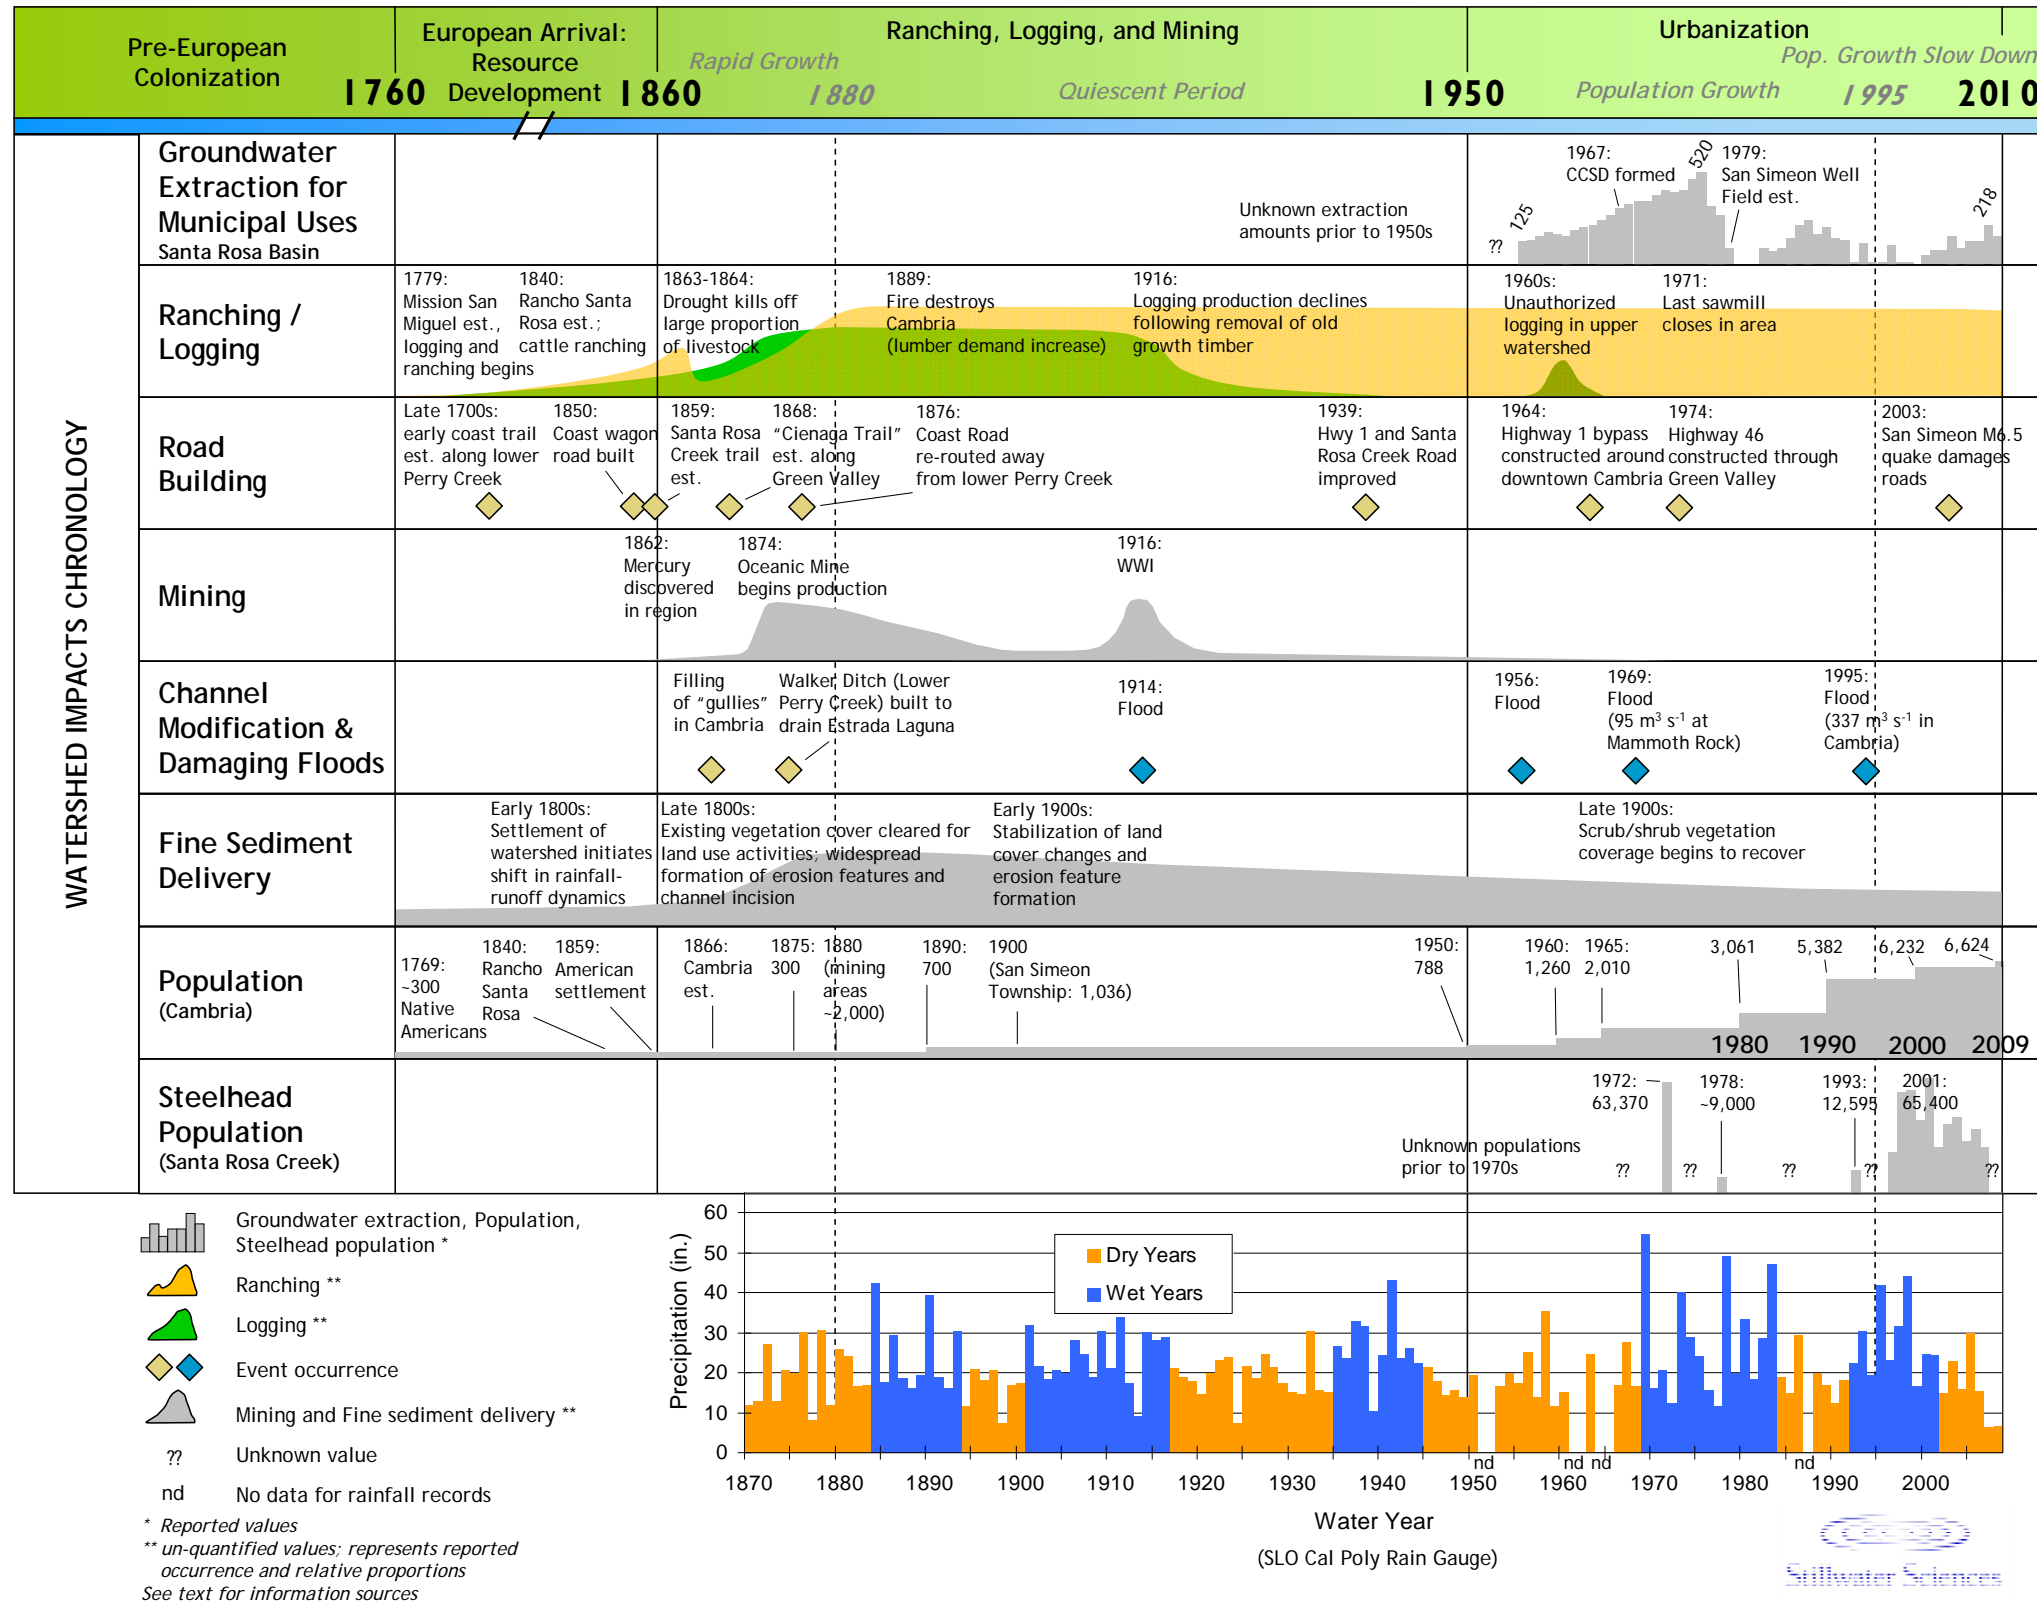
Figure 2-1. Chronology of watershed impacts and events. Precipitation records indicate periods of cumulatively wetter (blue) and drier (orange) periods in the watershed.

Looking at a watershed's past provides insight into natural physical and ecological trends in addition to the identification of human-induced changes over time. An informed forecast of future watershed conditions can therefore be made based on synthesizing the understanding of past and present conditions. The information presented in this section summarizes general historical conditions in the watershed dating back to pre-European settlement in an attempt to illuminate the historical (both natural and human-induced) events that may have had an effect on physical processes and ecological conditions in the watershed (Figure 2-1).

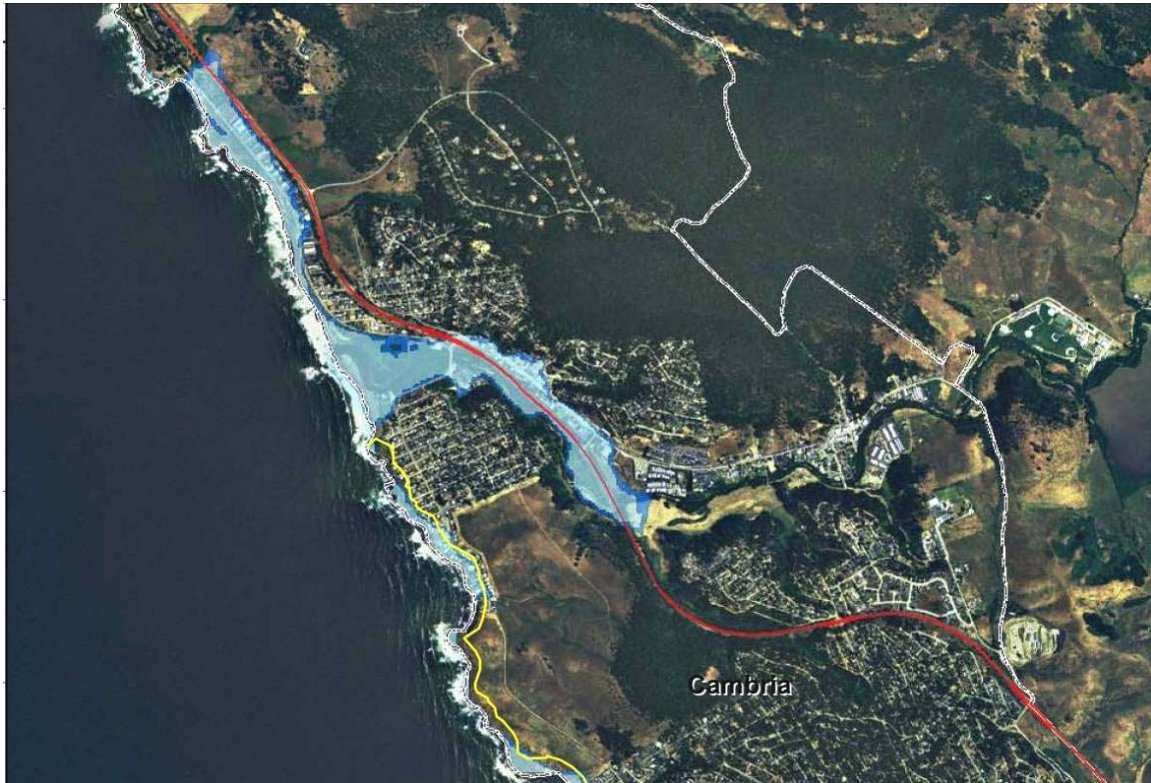
**Figure 2-6.** Predicted flood risk in 2100 in the Cambria area under a 1.4-m sea-level rise scenario. Light blue area is the current coastal base flood (approximate 100-year flood extent), dark blue area is the predicted coastal base flood under sea-level rise (current plus 1.4 m), yellow line is the predicted landward limit of erosion high hazard zone in 2100, and red line is Highway 1. Map used with permission from the Pacific Institute, Oakland, California.

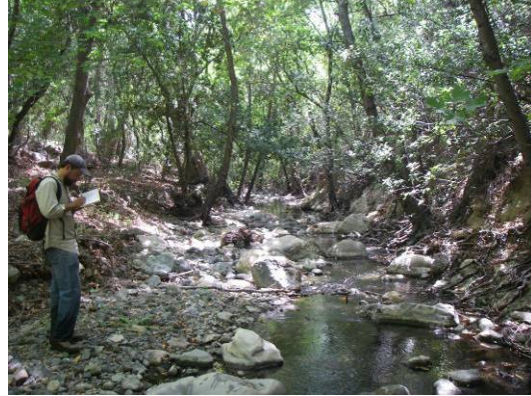
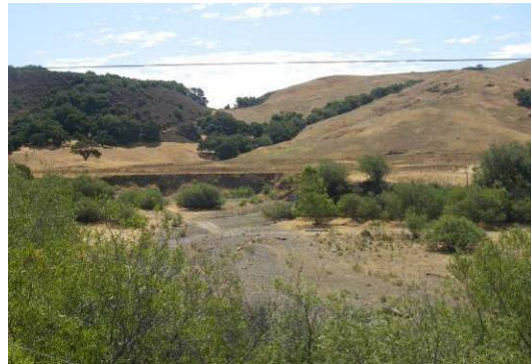
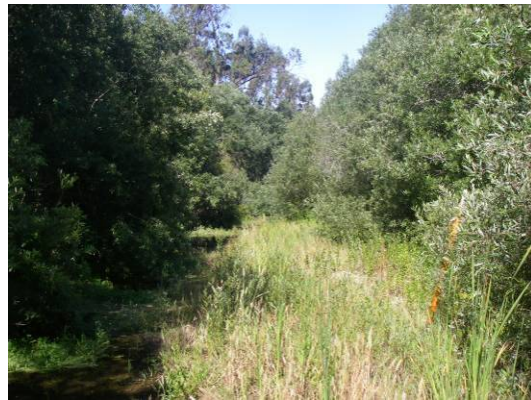
Examples of conditions in the upper, middle, and lower reaches of Santa Rosa Creek

Bedrock control returns at the junction with the lower reaches which have a sand-gravel bed and are moderately confined by terrain and development and show signs of aggradation before becoming tidally influenced near the low-gradient creek mouth (described in more detail below). Sediment delivered to the lower reaches from upstream Santa Rosa Creek, Perry Creek, and from local tributaries has resulted in a large amount of stored sediment in the reach. Banks are relatively stable, not least where extensive riprap protection exists.

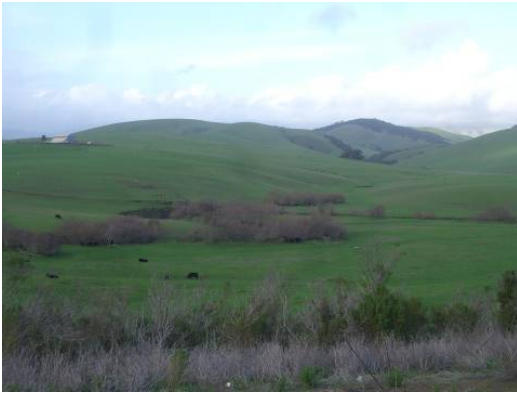
Perry/Green Valley Creek sub-watershed

Rosa Creek in terms of valley confinement, but unlike Santa Rosa Creek, Green Valley develops a very wide alluvial valley through its middle and lower reaches. These reaches are highly incised and actively eroding their banks. Together, Green Valley and Perry creeks transport a mixed sediment load skewed toward finer sediment that includes silt/fine sand to fine cobbles, with the dominant sediment bed particle size ranging from coarse gravel in the upper reaches to fine gravel in the lower reaches. The Perry/Green Valley Creek sub-watershed is another of the primary sources of fine sediment in Santa Rosa Creek.

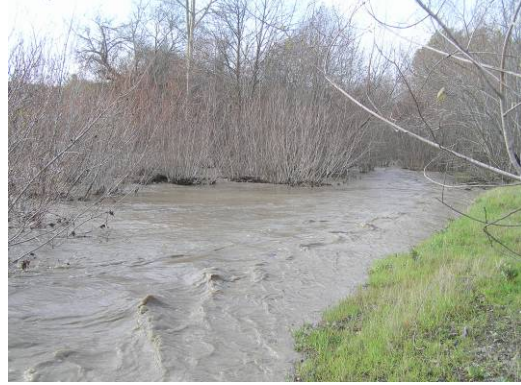
Inundated floodplain during high flows

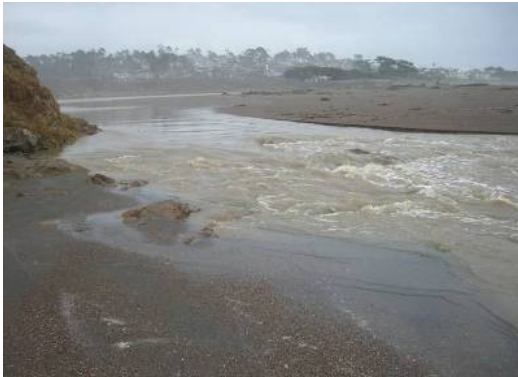
Open sandbar at the lagoon

The sandbar typically breaches after high rainfall and remains open for a week or more depending on streamflows; then the sandbar reforms to create the lagoon (M. Walgren, pers. comm., 2010). Often, high wave energy can also contribute to sandbar breaching. Reformation of the sandbar and closure of the lagoon occurs when lower stream discharges and lower-intensity wave action

facilitate onshore sediment transport and deposition at the mouth. Lagoon closure can take weeks to months, depending on the stream discharge and wave conditions. While the sandbar is open, the lagoon drains and is subject to the tides. From 1993–2007 the median date of sandbar closure was May 27, with the earliest closure on March 15 in 2007, and the latest closure on July 13 in 1998 (D. W. Alley & Associates 2008). During these years, date of sandbar closure was positively and significantly related to rainfall in the preceding water year, although the relationship was not strong ( $r^2 = 0.347$ ;  $P = 0.0209$ ;  $n = 15$ ).

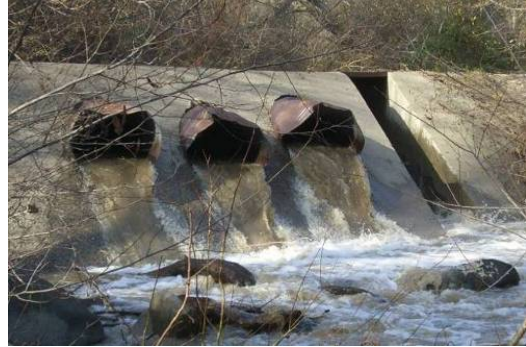
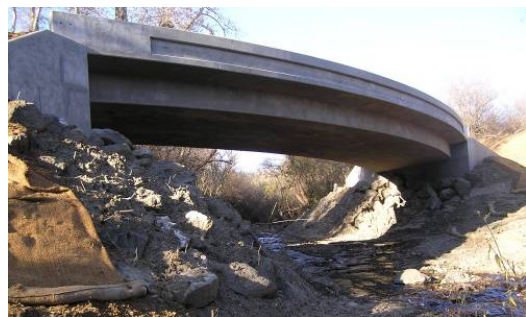
Ferrasci Road crossing before (above) and after (below) replacement

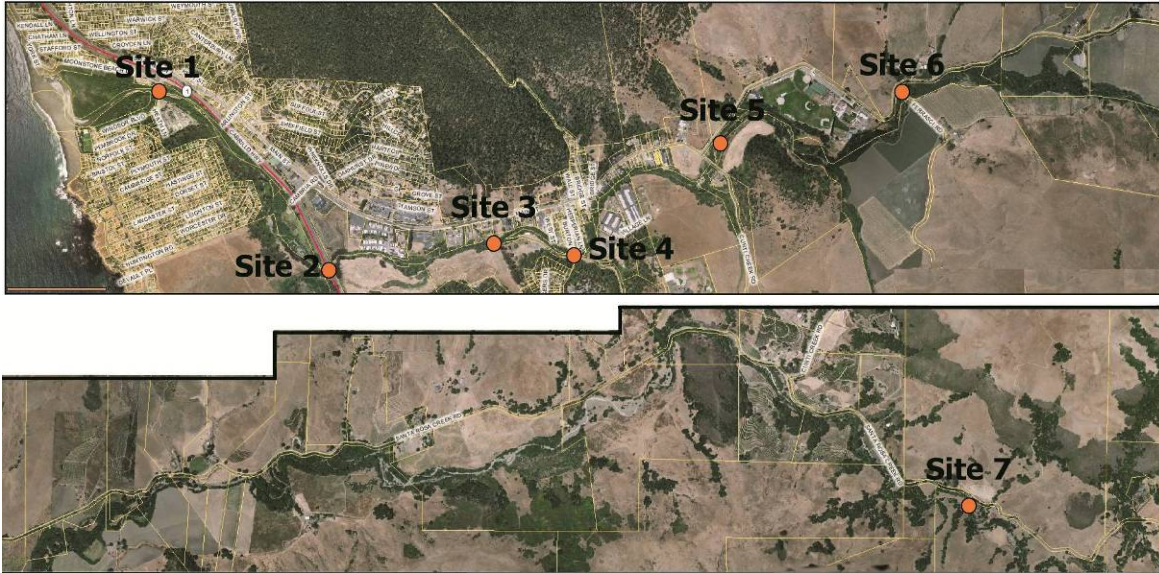
Figure 2-14. Benthic macroinvertebrate sampling sites on Santa Rosa Creek.

Sampling sites were selected in part based on personal communications with Mary Adams of CCAMP and Jennifer Nelson of CDFG, both of whom have experience on Santa Rosa Creek. Physical accessibility and permission for access from landowners also played a role in site selection. Selected sampling sites reflect a variety of land uses and human influences, including urbanization, agriculture, and ranching. The four downstream-most sites are located within the town of Cambria.

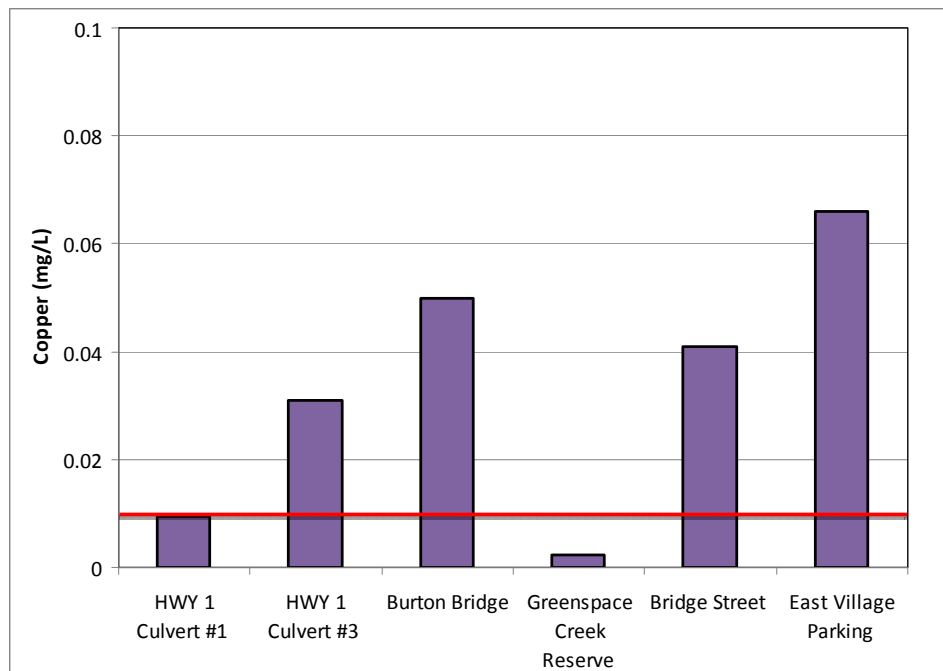
Figure 2-22. Dissolved copper in 2010 lower Santa Rosa Creek first flush samples. The red line is 0.01 mg/L, the CCRWQCB (1994) attention level for copper.

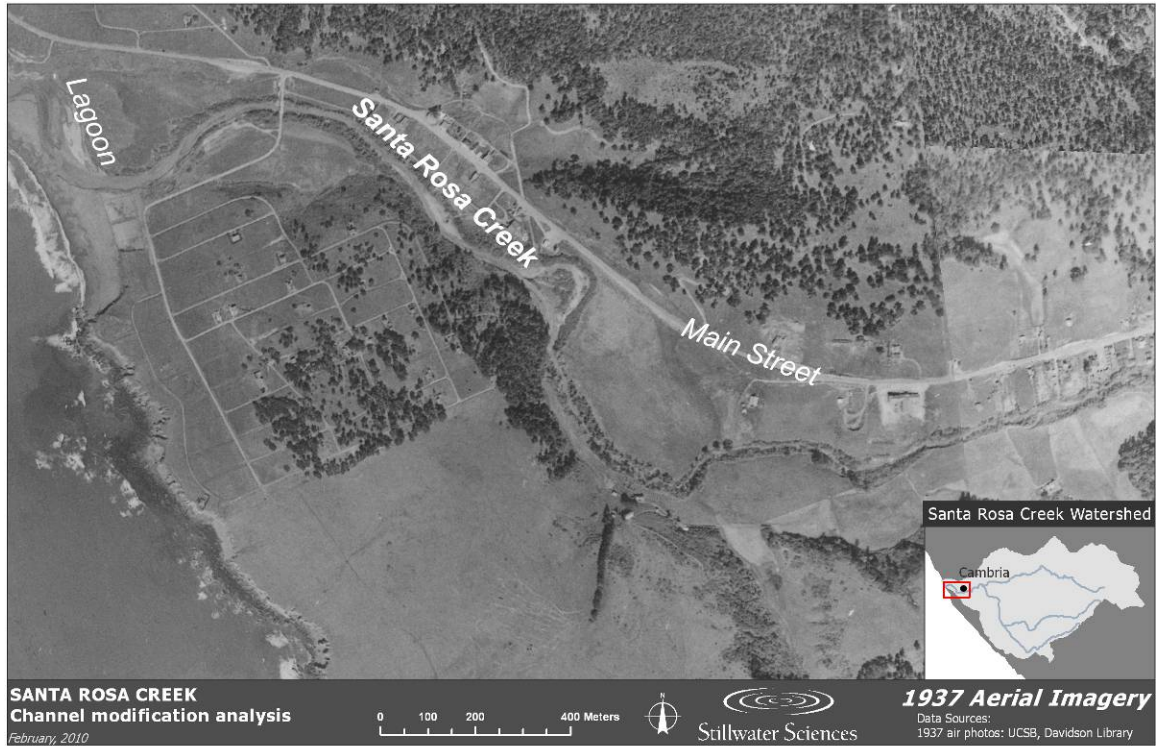
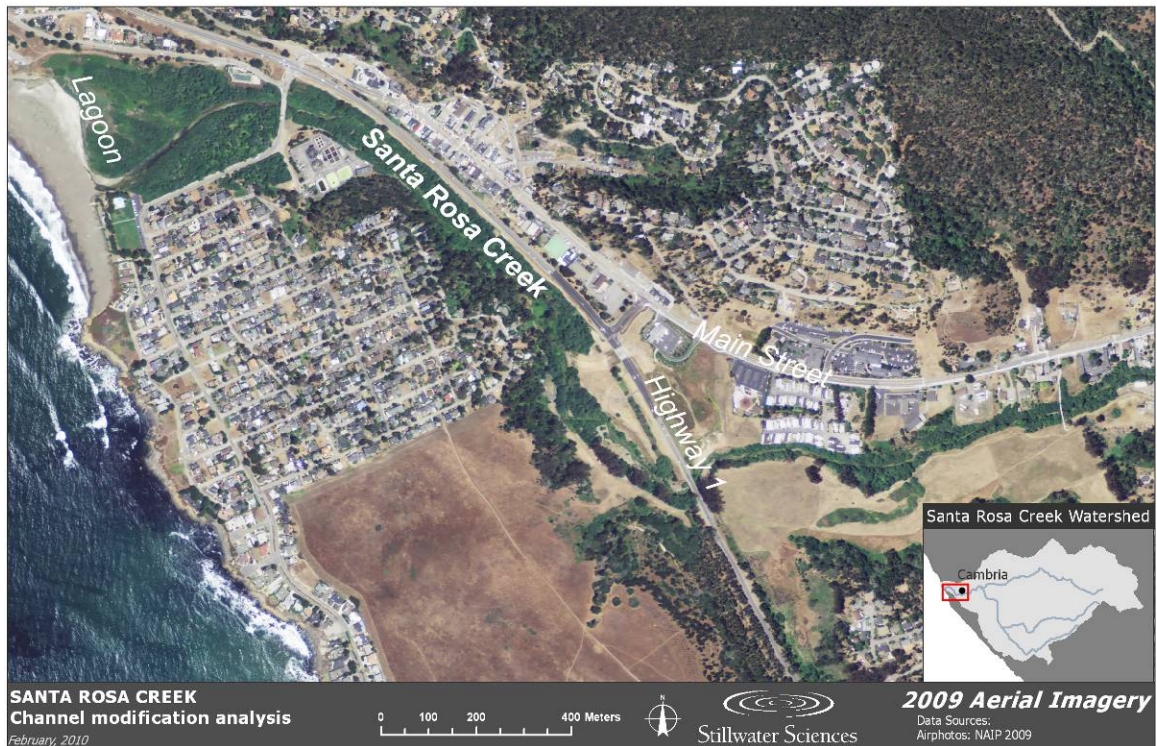
Figure 2-25. Historical (1937) and current (2009) aerial photographs of riparian corridor conditions in the lower reach of Santa Rosa Creek and near the town of Cambria.

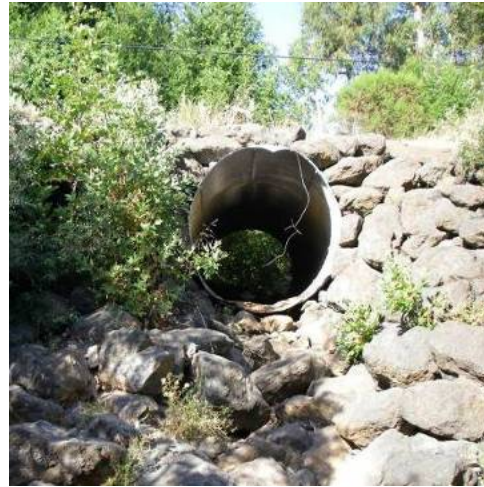
Culvert on Curti Creek

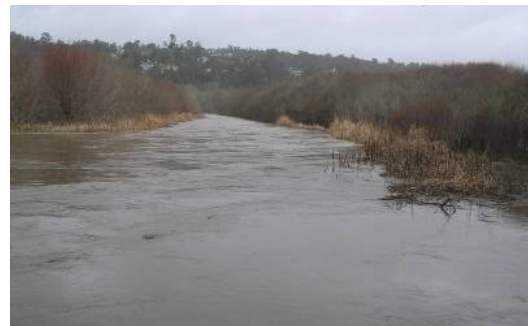
Full lagoon in winter

Coastal lagoons are fed mostly by freshwater streamflow and are generally separated from the sea by a sandbar, except when that sandbar is breached during high-flow events or when sea water overwashes the sandbar. Lagoon rearing has been demonstrated to be critically important for other central California coast steelhead populations, with significantly higher growth rates and ocean survival by steelhead that reared in lagoons, even with lagoon water temperatures as high as 75°F (24°C) (Smith 1990, Hayes et al. 2008, Bond et al. 2008). While no studies of lagoon rearing, growth, and survival have been carried out in Santa Rosa Creek, these findings from other central California coast watersheds highlight the potential importance of the Santa Rosa Creek lagoon for steelhead rearing. Since larger smolts tend to have higher ocean survival, growth during lagoon rearing may increase ocean survival of steelhead smolts. It appears that if lagoons are well-mixed (i.e., not salinity stratified), or comprised of mostly freshwater, they can maintain a relatively cool, well-oxygenated, and food-rich environment that provides high quality habitat for juvenile steelhead (Smith 1990). This can potentially relax to some degree the density-dependent bottleneck occurring in stream habitat and provide a high growth environment and adjustment to a saline environment that improves ocean survival for both stream and lagoon reared fish. Conversely, when lagoons are highly saline, or salinity-stratified, they collect heat in the lower saltwater layer, have relatively lower dissolved oxygen levels, and typically have unsuitable conditions for rearing.

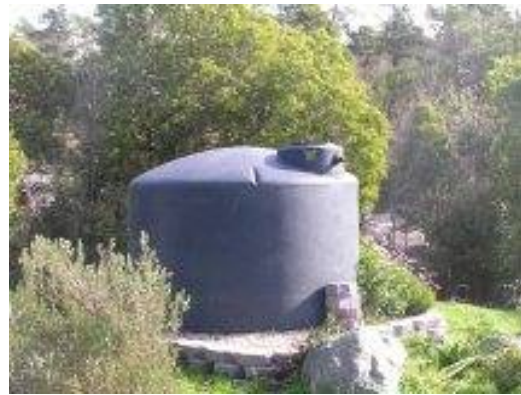
Storage tank in Santa Rosa Creek watershed

Off-stream water storage of extracted groundwater and riparian diversions for domestic and agricultural uses, which would divert water during higher instream flow conditions in the winter and store it for use in the summer and fall, is one way of achieving additional instream flows for steelhead rearing and fall migration during dry water years. Water for off-stream storage would be diverted in winter only, with an elimination of spring, summer, and/or fall water rights. Off-stream closed water storage facilities (e.g., above-ground water tanks, cisterns, etc.) are maintained along several tributaries in the watershed; it is recommended that opportunities to increase their efficiency as well as to increase the number of facilities in strategic locations be pursued.

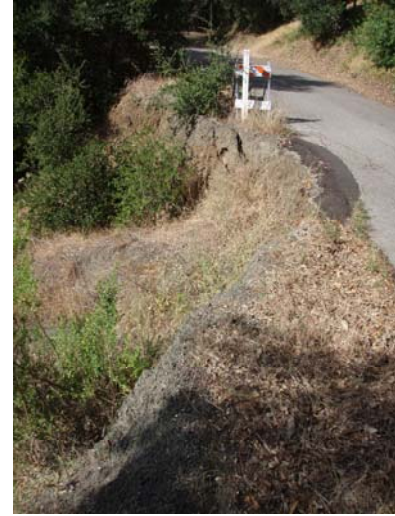
Erosion at Santa Rosa Creek Road

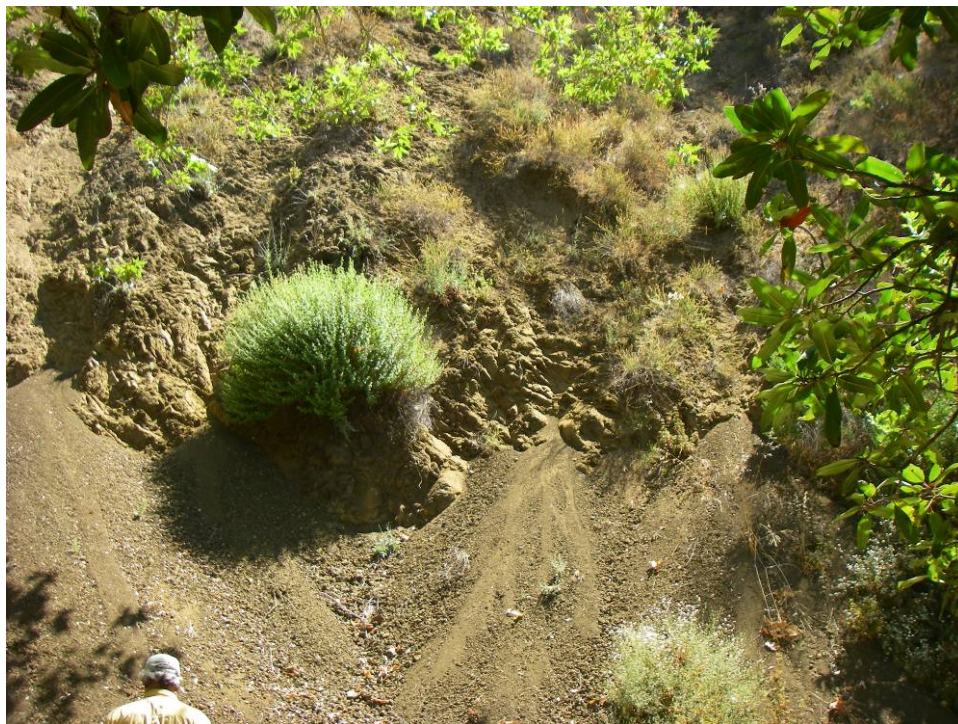
Figure 3-4. An exposure of fine-grained, weak shale of the Monterey Formation in the Curti Creek subwatershed (note person in foreground for scale).

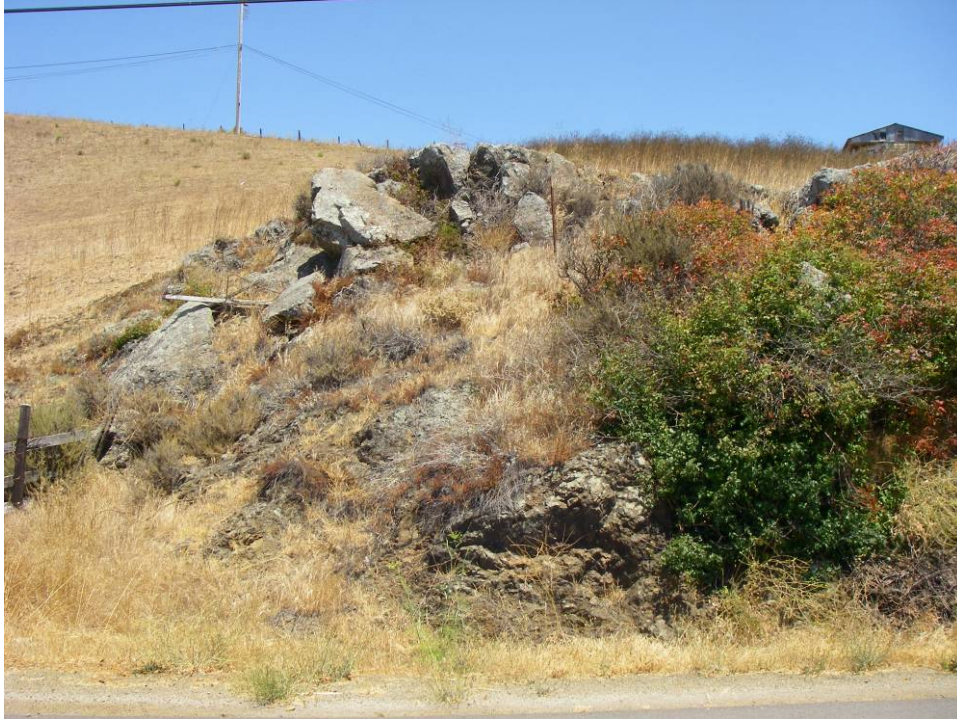
**Figure 3-5.** An exposure of coarse-grained, weak graywacke of the Franciscan mélangé along Santa Rosa Creek Road. Large fractured blocks of the rock unit lie upon the top of the outcrop.

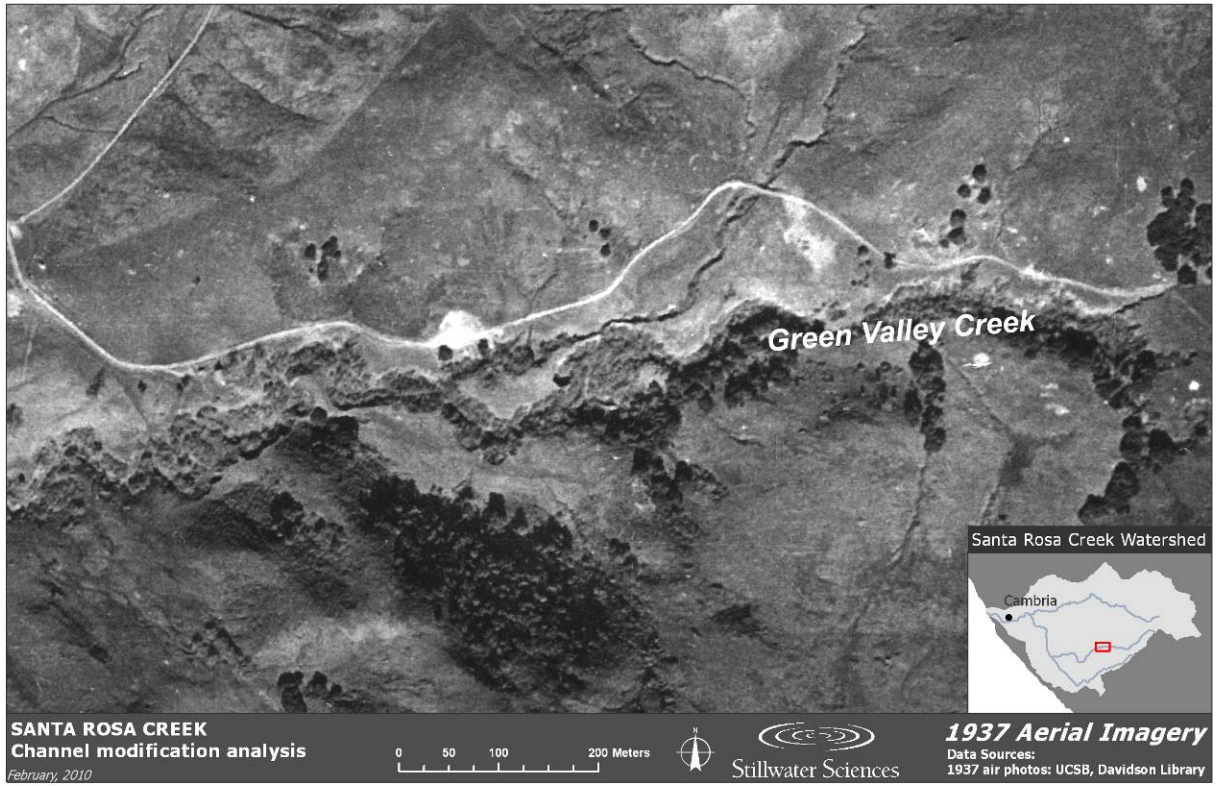
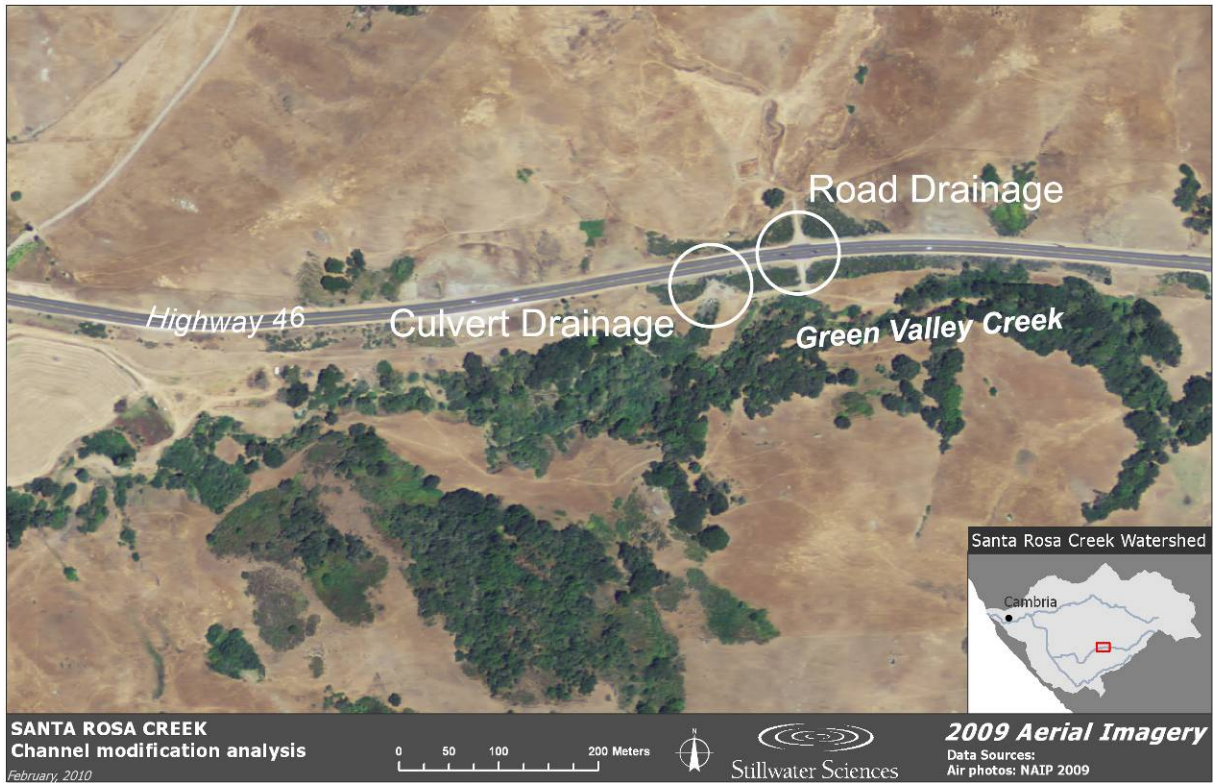
Figure 4-13. Historical (1937) and current (2009) aerial photographs showing the reach of Green Valley Creek with the large culvert drainage adjacent to Highway 46.

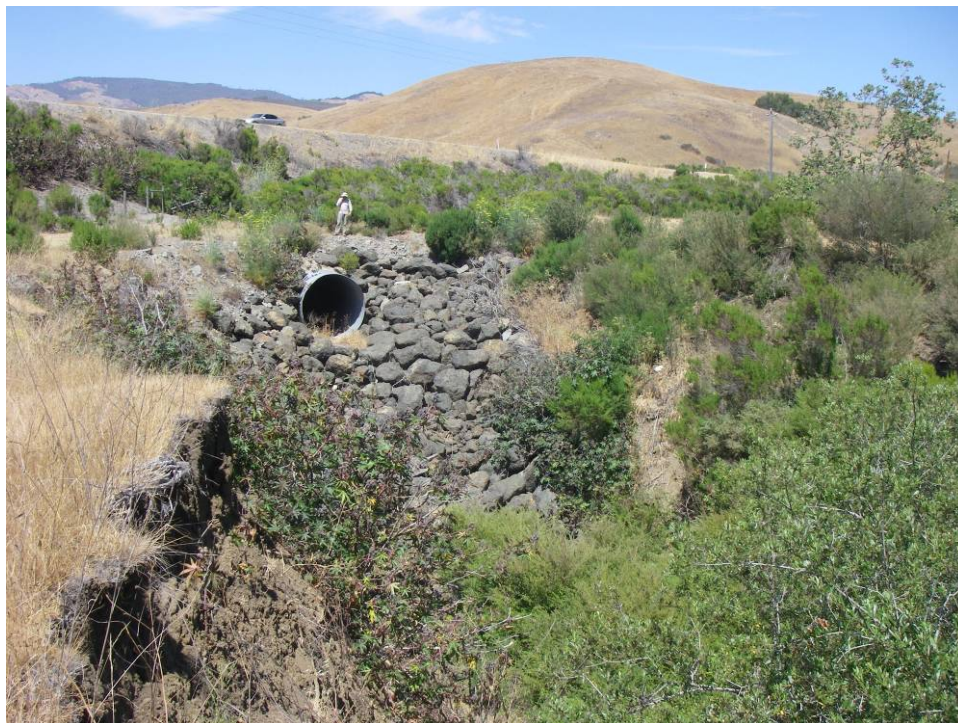
**Figure 4-14.** View looking upstream at a large, 7-ft diameter culvert that passes beneath Highway 46 and drains into Green Valley Creek.

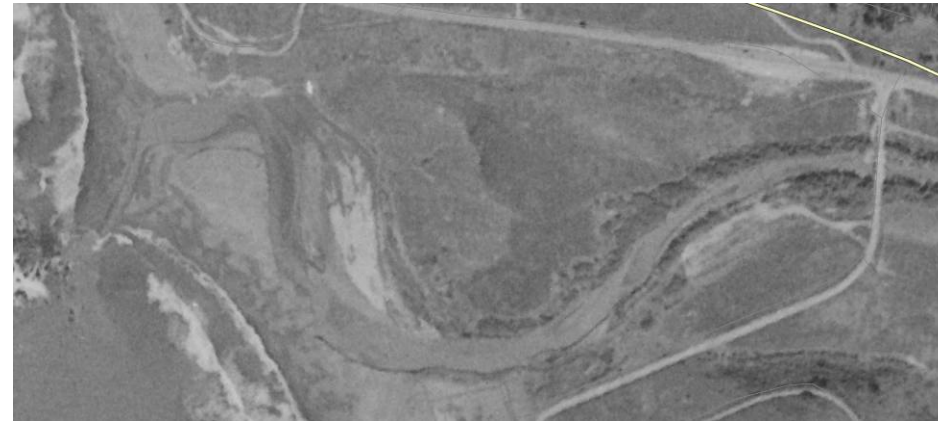
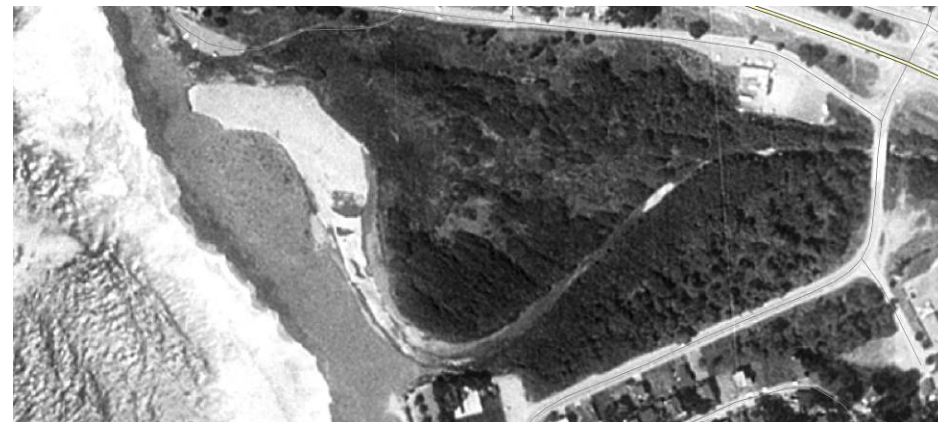
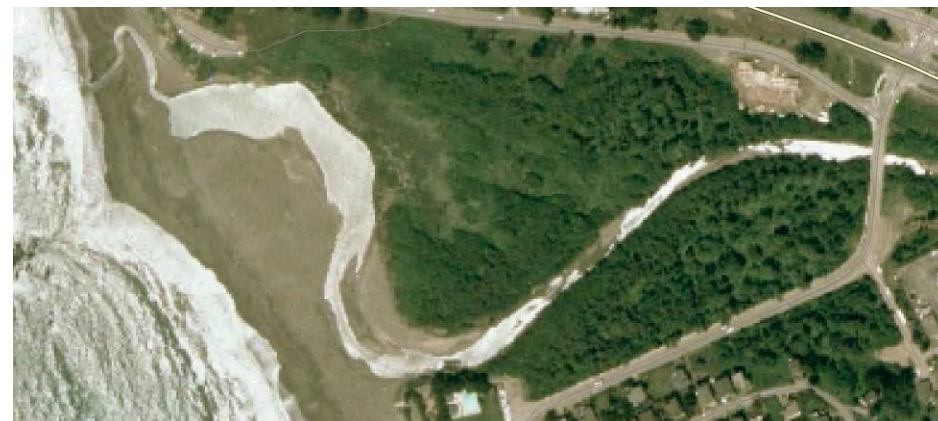
Figure 4-18. Historical topographic map and aerial views of the Santa Rosa Creek lagoon. The lagoon has generally maintained a similar planform shape since the early 1900s, with few exceptions (e.g., 1986). Also shown are examples of a breached sandbar during higher stream flow conditions (e.g., 2005) and a closed sandbar during lower flow conditions (e.g., 2009).

The general planform of lower Santa Rosa Creek and the lagoon have remained relatively static in recent time, as seen in one historical topographic map from 1919 and a series of eight historical and present-day aerial photographs taken since 1937 (Figure 4-18). Two main features are made apparent when examining these historical views of the lagoon: (1) the mouth is nearly always positioned on the north end of the beach adjacent to the marine terrace, with few exceptions (e.g., 1986), and (2) the amount of vegetation cover adjacent to the lower creek channel and lagoon appear to have increased considerably between 1937 and 1976. The “upcoast” lagoon orientation is common among lagoons of similar size along the central and southern California Coast. Although no known aerial photographs of the lagoon were taken prior to the 1930s, we can infer from Julien Estrada’s sketch diagram of his holdings of Rancho Santa Rosa in 1841 that the lagoon may have exhibited a similar planform whereby the creek and lagoon sharply curved from the south to the north just before discharging to the ocean (see Figure A-2 in Appendix A). However, given that this diagram was not drawn to scale and there are insufficient landmarks shown, it is possible that the northerly “swing” of the lower creek may represent the portion of Santa Rosa Creek below present-day Highway 1 rather than the lagoon. The vegetation cover as viewed in the 1937 aerial photograph is limited to the a riparian corridor that lines the lower creek channel as it enters the lagoon, but minimal woody vegetation is present upon the adjacent floodplain areas. By 1976, the floodplain areas supported a denser vegetation cover comprised of woody scrub/shrub, riparian forest, and wetland plants (see Figures 1-6 and 4-16). The reason for this lack of vegetation cover in 1937 is unknown, but may be due to general land clearing that occurred throughout the watershed during the late 1800s and early 1900s. The subsequent re-vegetation of the lagoon area has implications maintaining the lagoon’s position (i.e., vegetation providing bank strength) and promoting overbank deposition (i.e., decreased competence due to presence of roughness elements).

Overall, it can be inferred from the historical aerial photographs shown in Figure 4-18 that neither net aggradation nor erosion has occurred during the past 70-plus years based on the following: (1) the lower stream channel and lagoon have maintained a relatively static position (i.e., no meandering or avulsions); and (2) the lower stream channel exhibits a similar, albeit transitory, bar and pool morphology. This has positive implications for the continued functionality of an ecologically-important lagoon.
