WATERSHED FISHERIES REPORT AND EARLY ACTIONS

A Study of the Upper Salinas River and Tributaries

Report to the California Department of Fish and Game

Upper Salinas-Las Tablas Resource Conservation District

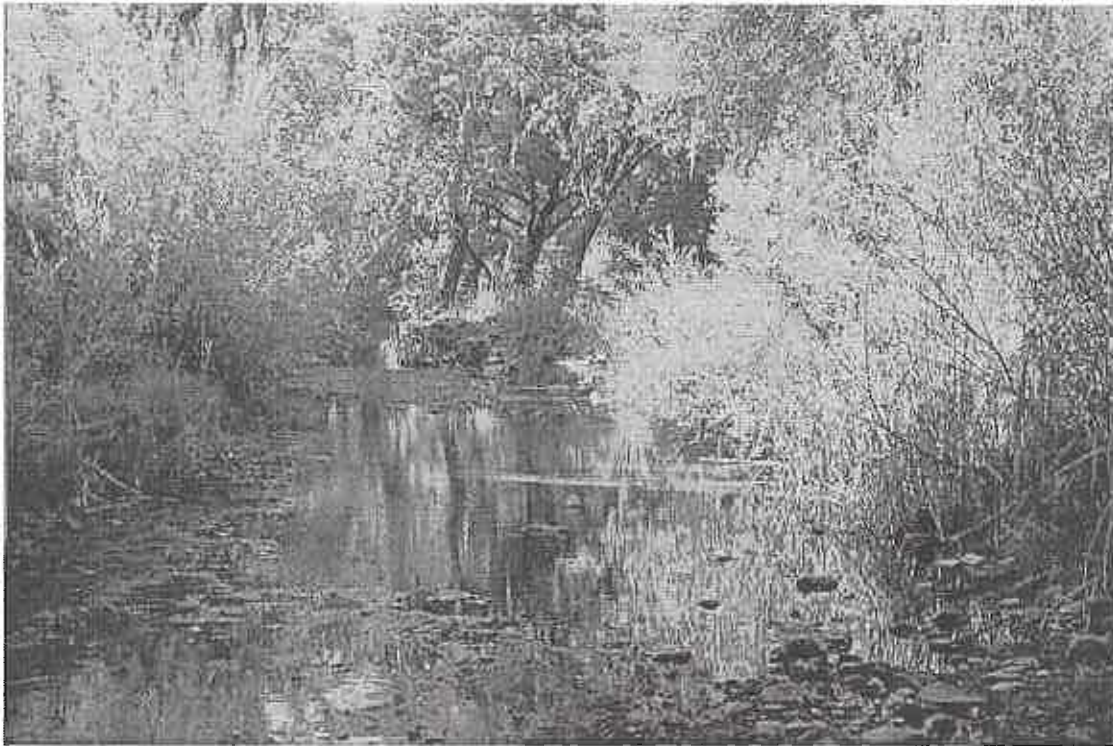
Atascadero Creek at 3 bridges area

In this survey eight locations were evaluated and six had steelhead present Kathleen Valley small upstream of McLean Spring, and in Hale Creek in a slide area. A pool on Atascadero Creek upstream of Hale Creek had steelhead with different classes of age. Plum Orchard and Atascadero Creek at Three Bridges, upstream of the middle bridge, had steelhead young of year and yearling steelhead. Steelhead were also found in a pool in Atascadero Creek at Three Bridges (Sycamore Road Bridge).

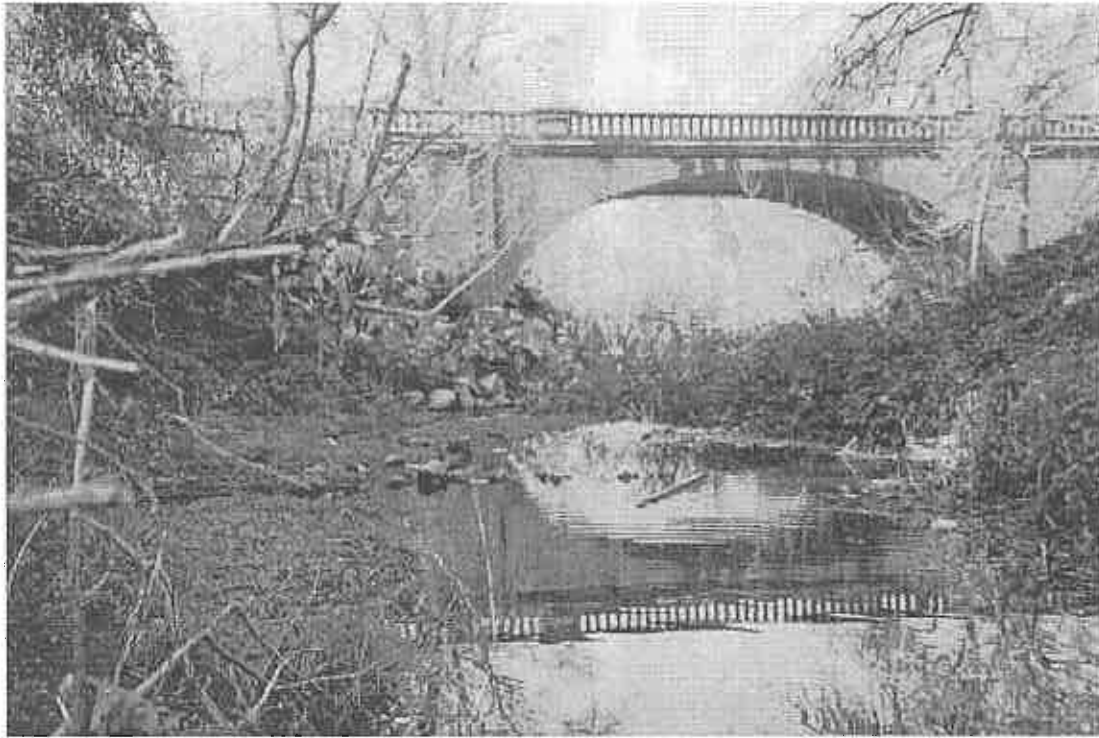
Atascadero Creek at the West Mall bridge (old Highway 41)

During the course of this study, stream flow is perennial upstream of 1,400 feet and intermittent from 1,400 feet to the confluence with the Salinas River. Water quality is similar to that at the West Mall Bridge. As the water flows decrease during the fall, the stream becomes increasingly stagnant and musty odors are noticeable. This stagnant condition is more apparent downstream of the bridge during the lowest flows.

As mentioned above, the 1949 aerial photos indicate considerable channel vegetation. Most of that vegetation disappeared by 1978. Bank coverage prior to the Water Company's restoration project in 2000 was 0 percent on the left bank and 25 percent on the right bank at the 500 foot cross-section. After the restoration, the bank coverage has improved to 75 percent on both the left and right banks. Most of that vegetation is grasses. Overcoverage is 0 percent. The reestablishment of riparian vegetation may initially require supplemental irrigation.

Vehicle use in both Atascadero Creek and the Salinas River is quite evident at this reach. Tire tracks and vehicle debris is prevalent, even during stream flow. Frequent OHV recreational use of the stream and river has been observed. Compaction of the channel sands and gravels as well as the destruction of young riparian vegetation is an obvious result.

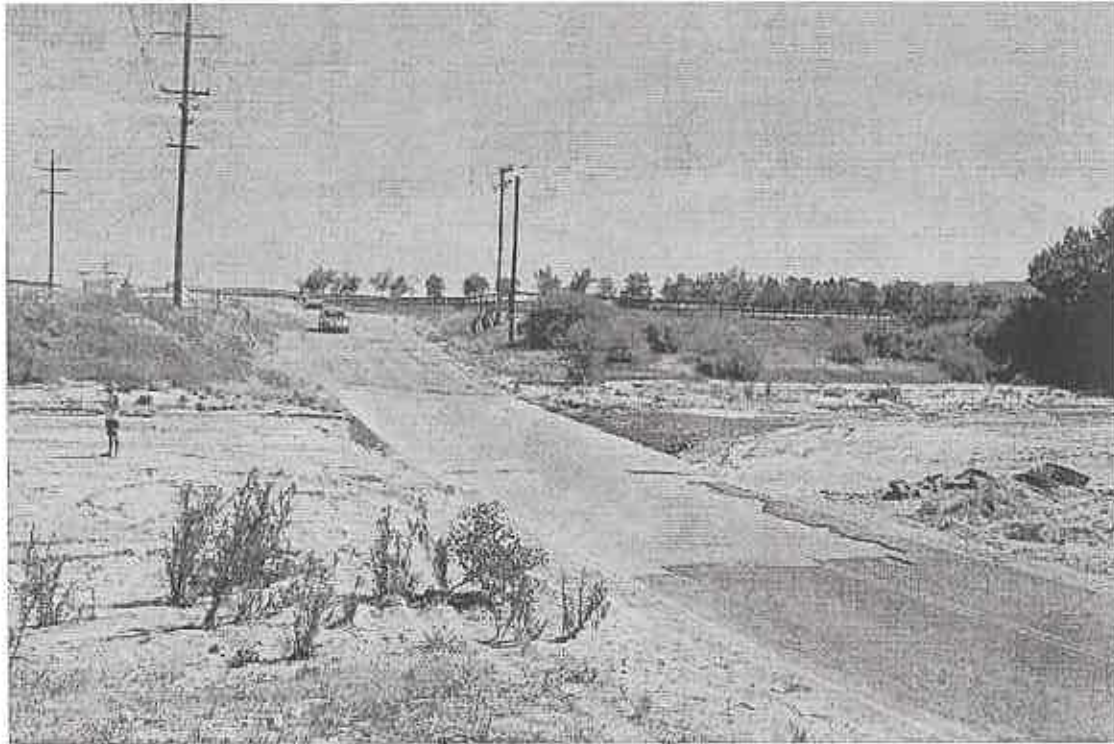
Estrella River at the North River Road crossing near the confluence with the Salinas River

The Estrella River channel is experiencing numerous areas of serious bank erosion. Some of this erosion is due to the loss of channel riparian vegetation. Suspended sediment in the Estrella is very high. During large rainstorms, sediment levels of over 90 cubic centimeters per 1000 milliliters have been recorded. The Estrella may be a major cause of excessive sediment in the Salinas River. (Refer to the Estrella Cross-Section at the end of this report)

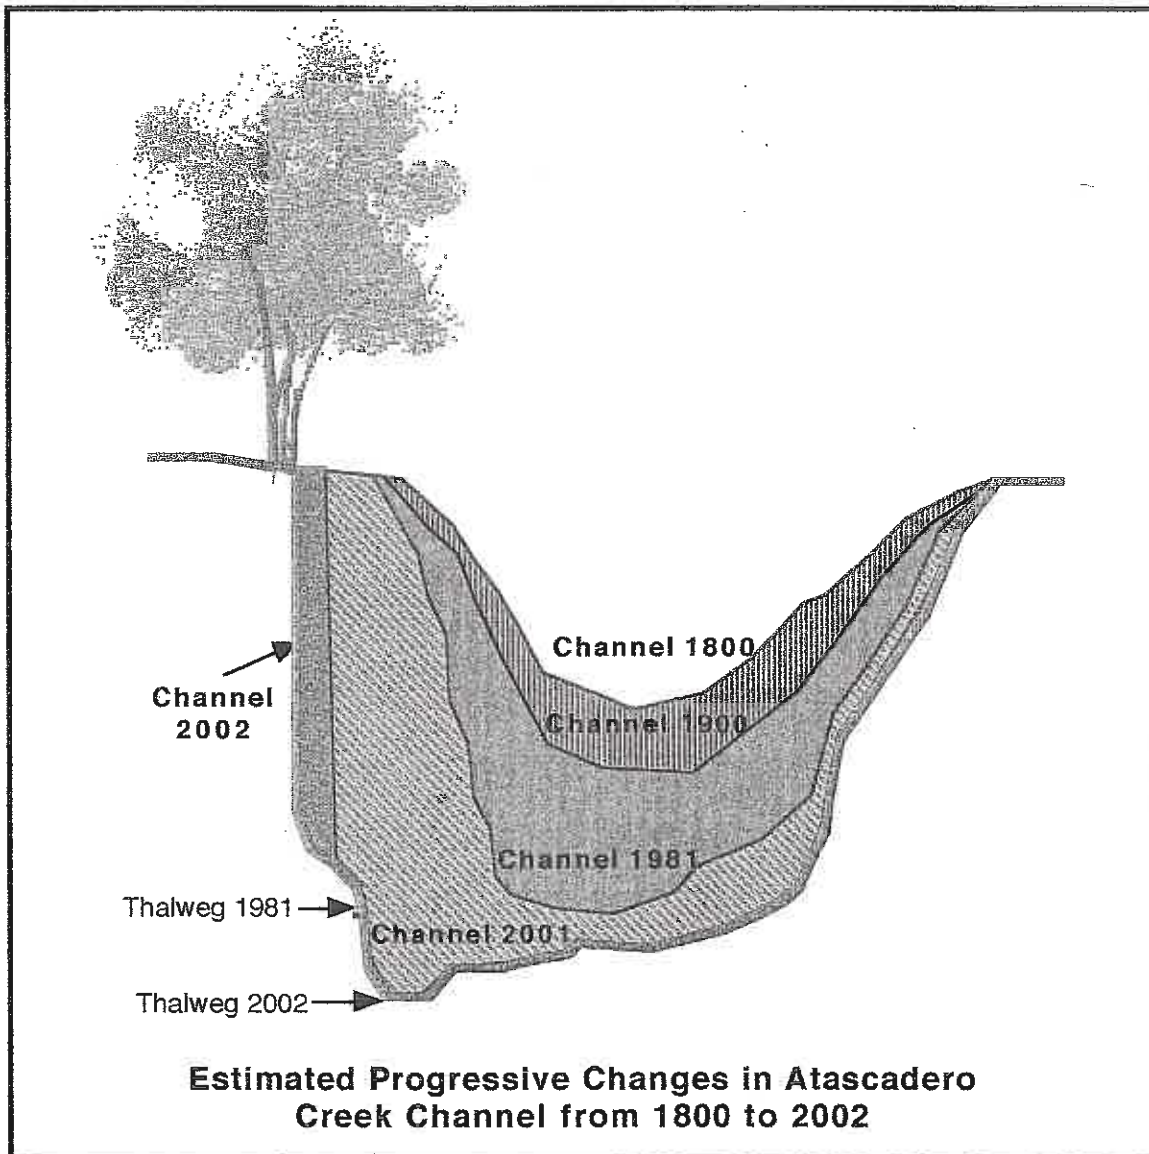
Site Location of Cross-Section: 350 feet southwest of West Mall Bridge

the bank edge. The channel will continue to broaden as Atascadero Creek tries to regain a new floodable terrace at a lower elevation. Hardening of the channel banks with concrete or similar hard surfaces tends to increase flow velocities even more, greatly increasing the potential for erosion on opposite banks.

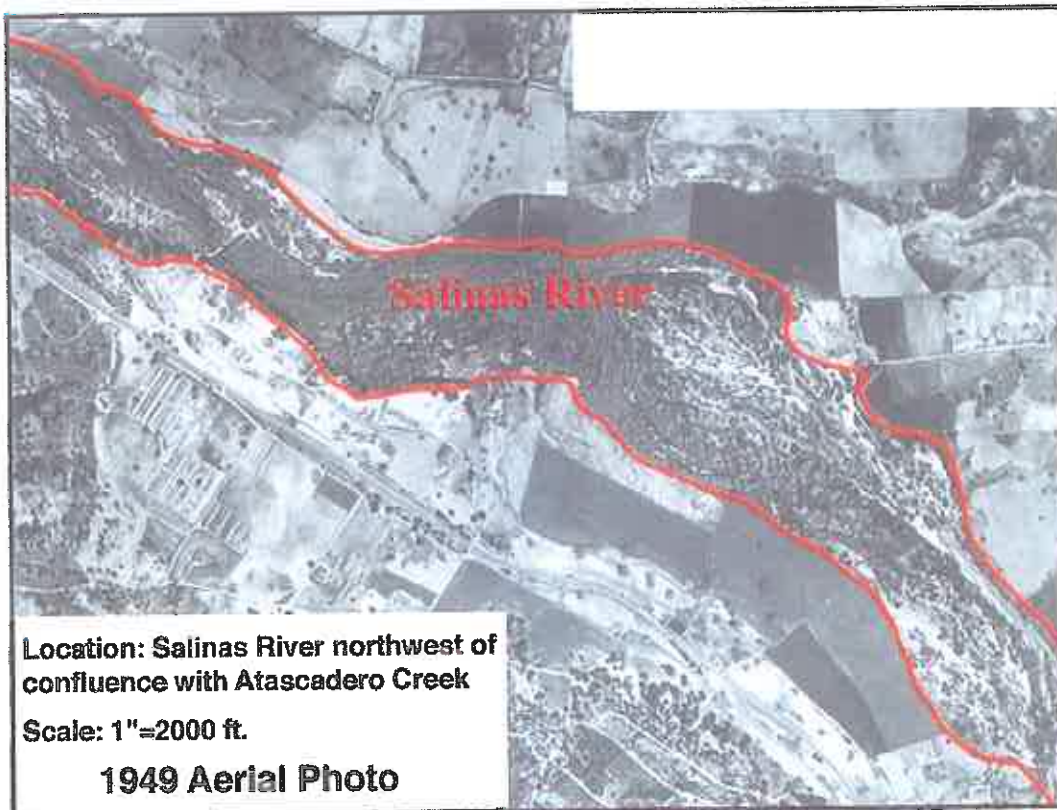
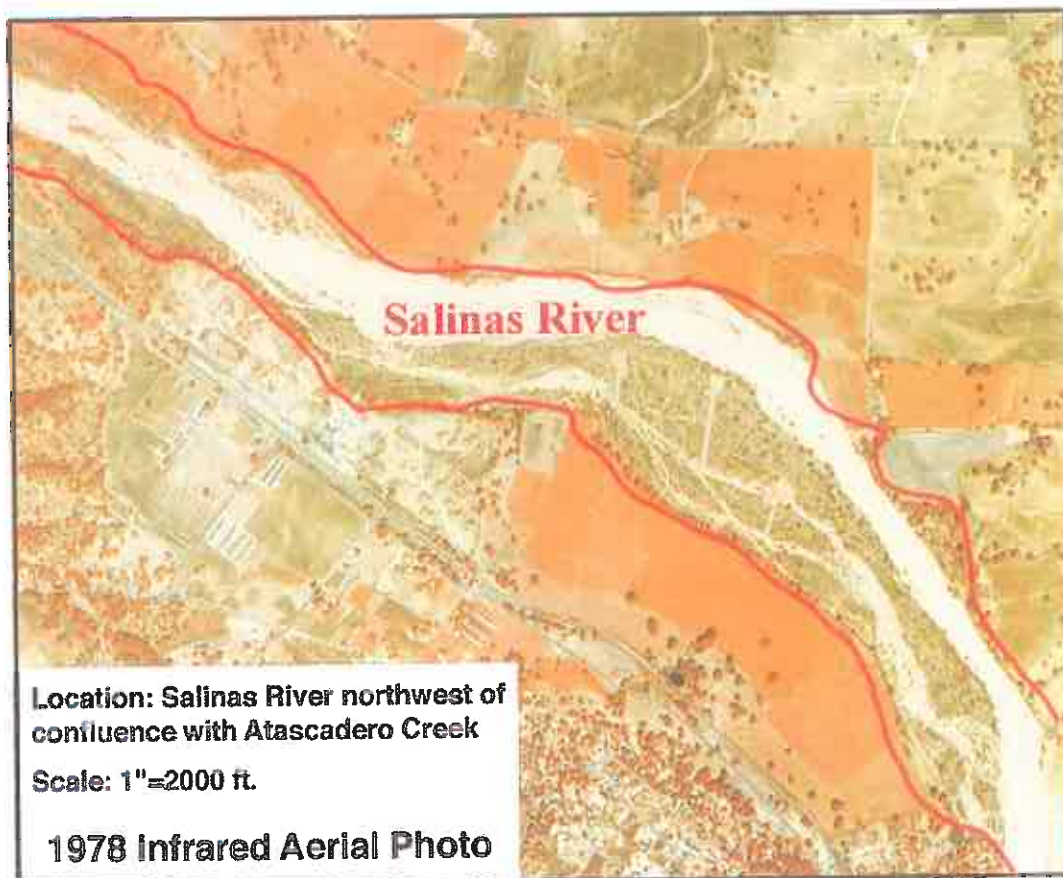
Salinas River Vegetation Comparison Study

The following photo vegetation comparisons were conducted of two reaches on the Salinas River. The first location is a reach of the Salinas River at the northeast edge of the City of Atascadero. The 1949 photo of this reach indicates a channel vegetation coverage of 90 percent. By 1978, the channel riparian vegetation cover had decreased to 15 percent for the same reach. The second aerial photo comparison is of the Salinas River within the City of Paso Robles, south of the 13th Street bridge. The 1949 aerial photo of the Salinas River in Paso Robles shows riparian vegetation covering 75 percent of the channel. By 1978, the channel vegetation of this reach had dwindled to 20 percent. Also note that both the 1949 and the 1978 photos show a small tributary that met the Salinas River about where Walmart is located today. The riparian vegetation in that tributary was dense in 1949. In the 1978 infrared photo, much of the riparian vegetation was gone. That tributary was later placed in a concrete culvert under the Walmart parking lot.

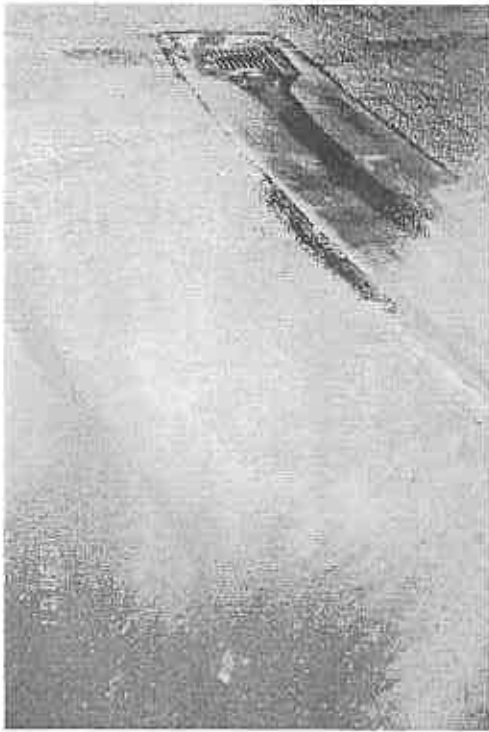
Oil pollution from streets and parking lots drains into creeks

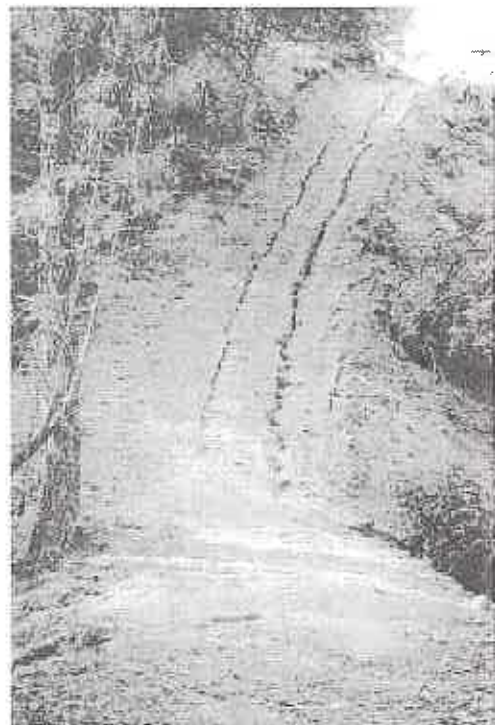
Soil eroded from roads creates sediment in streams

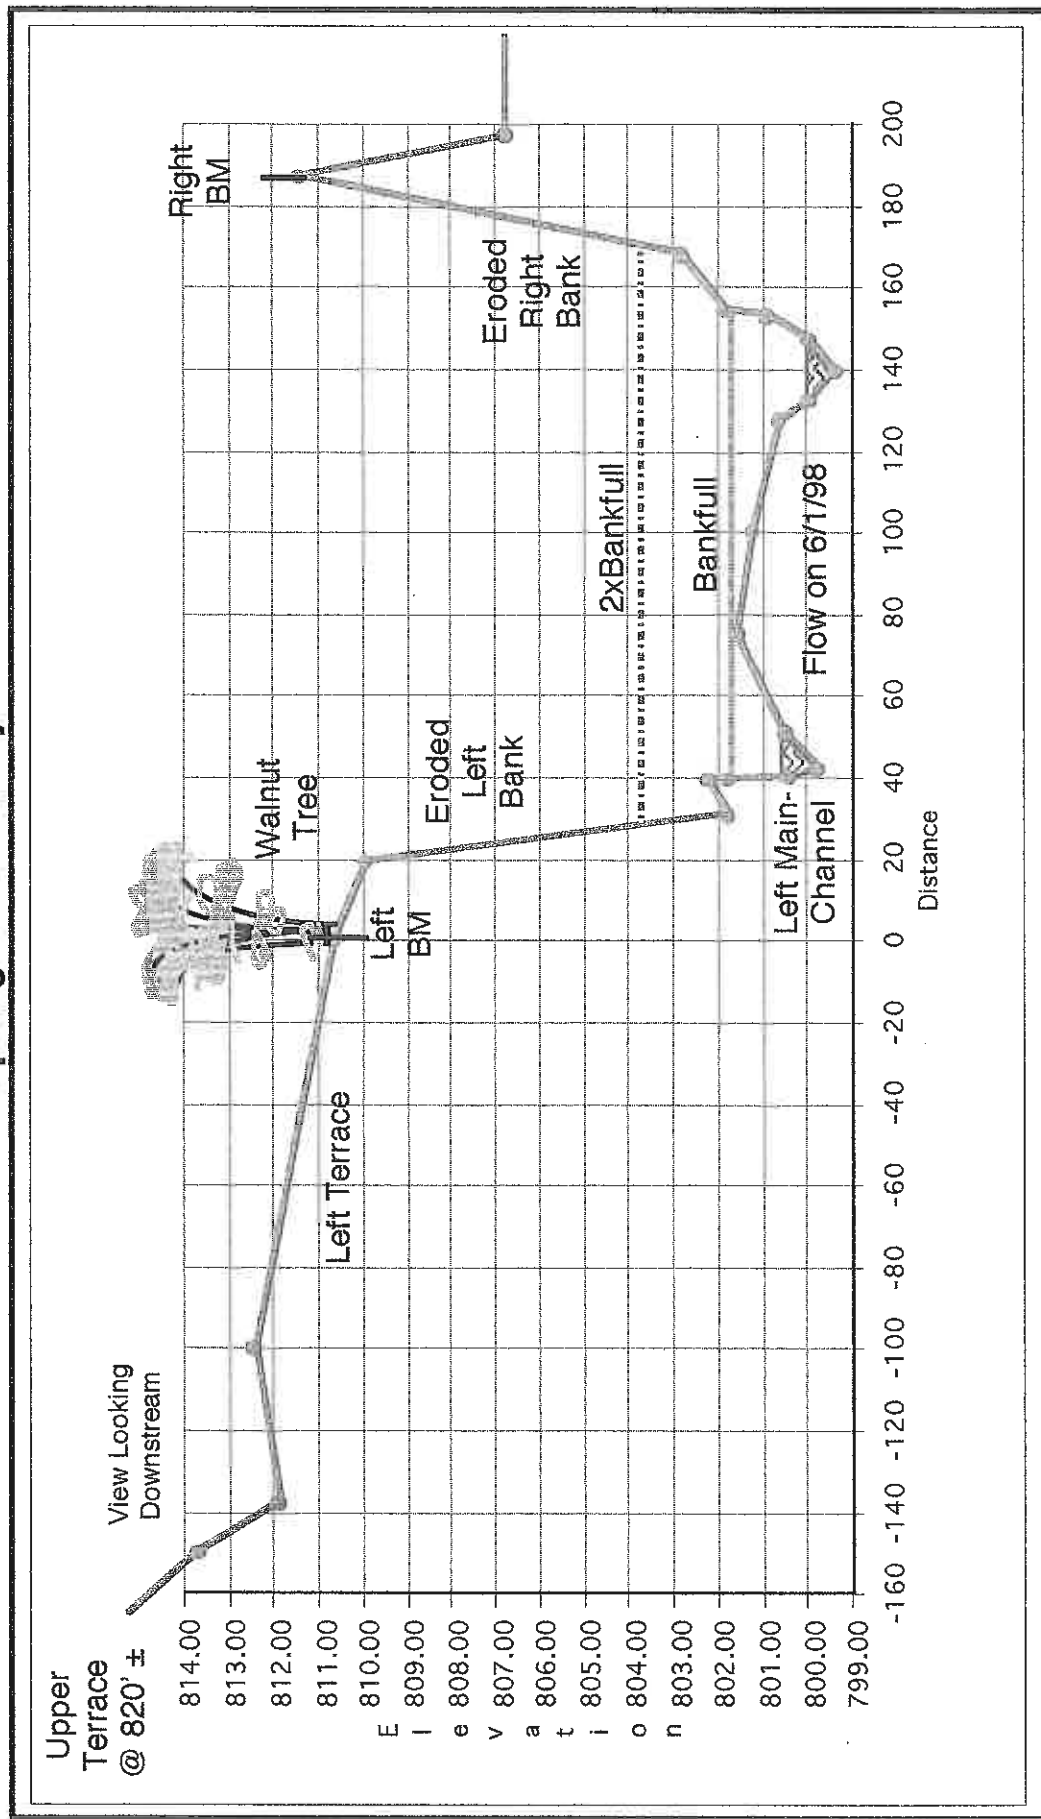
Cross-Section Atascadero Creek 500 Feet from Confluence of Salinas River Spring 1998 Survey

17	100	801.28	4.45				805.73	Bkft Flow est. from typ. watershed*: 772 cubic ft./sec
18	127	800.70	5.03				805.73	WD Ratio: 53 (Extremely high WD ratio)
19	132	799.98	5.75				805.73	Entrenchment Ratio: 1.23 (Highly entrenched)
20	139	799.39	6.34				805.73	Sinuosity Ratio: 1565/1400: 1.12 (Low Sinuosity)
21	147	800.00	5.73				805.73	
22	153	800.95	4.78				805.73	
23	154	801.90	3.83	Bkft			805.73	
24	168	802.89	2.84				805.73	
25	187	811.50	3.13		812.04	2.59	814.63	Right Plastic BM: 112.04
26	197	806.83	7.8				814.63	Right Terrace (located between Salinas R. and Atas. Cr.)
27								
28								
29	* Salsipuedes Creek Watershed Gage Data Average for 14 yrs.: 59 cu. ft./sec/sq. mi. (return of 1.5 yrs. on average)							
30	This figure is believed to be high; Atas. Cr. Watershed anticipated to receive 2/3 flow of Salsipuedes Cr. Watershed							
31	Atas. Creek est. Bkft flow of 39 cu ft./sec/sq. mi. since this area typically receives less rainfall than Pozo area

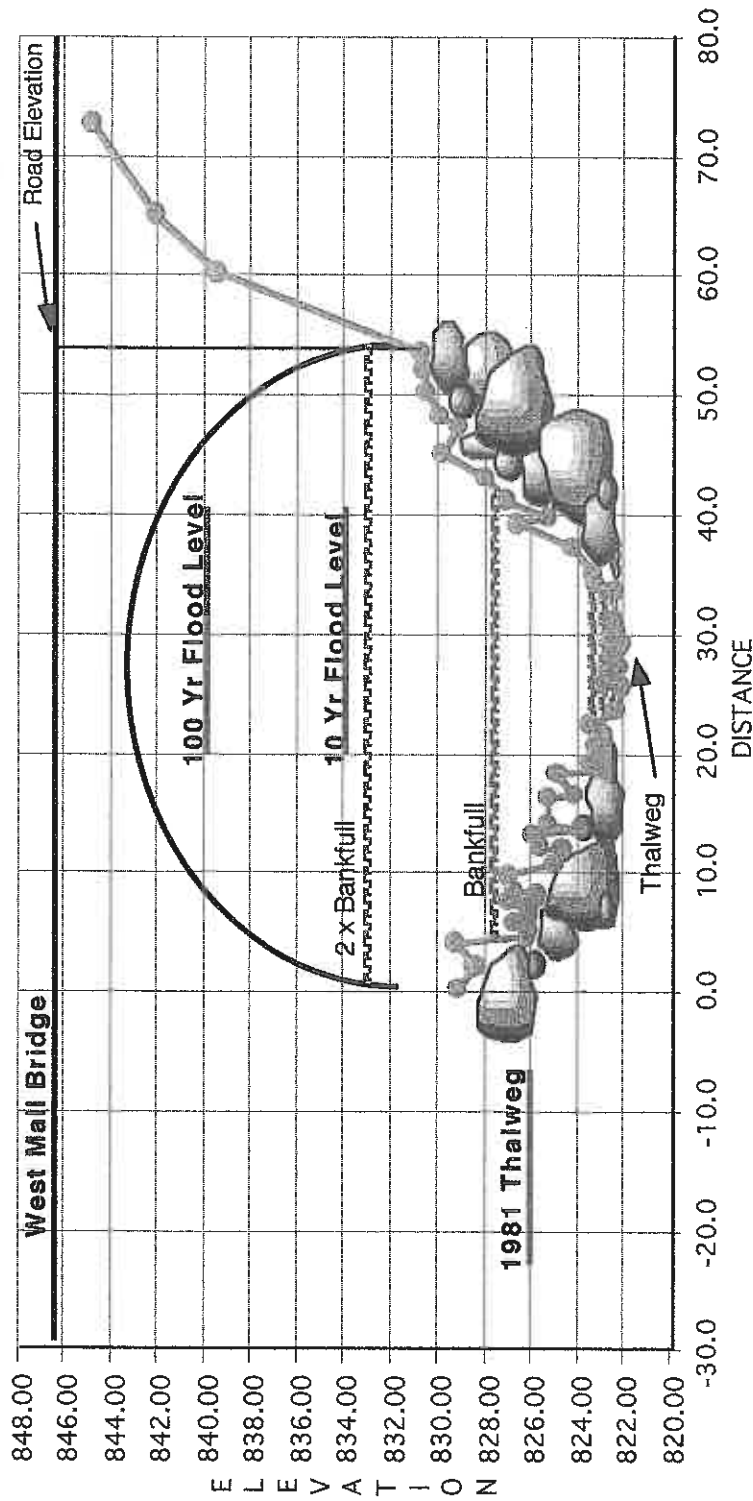
Distance 4,950 ft. from
Salinas R. confluence

In addition to the eroding banks, the channel bottom is degrading. The channel thalweg has eroded vertically almost 4 feet within the past 21 years, an average of .2 feet per year. At cross-section 4,950, the entrenchment ratio is 1.42 to 1. This site, located on the southwest side of the bridge, has been armored with 2 foot riprap boulders.

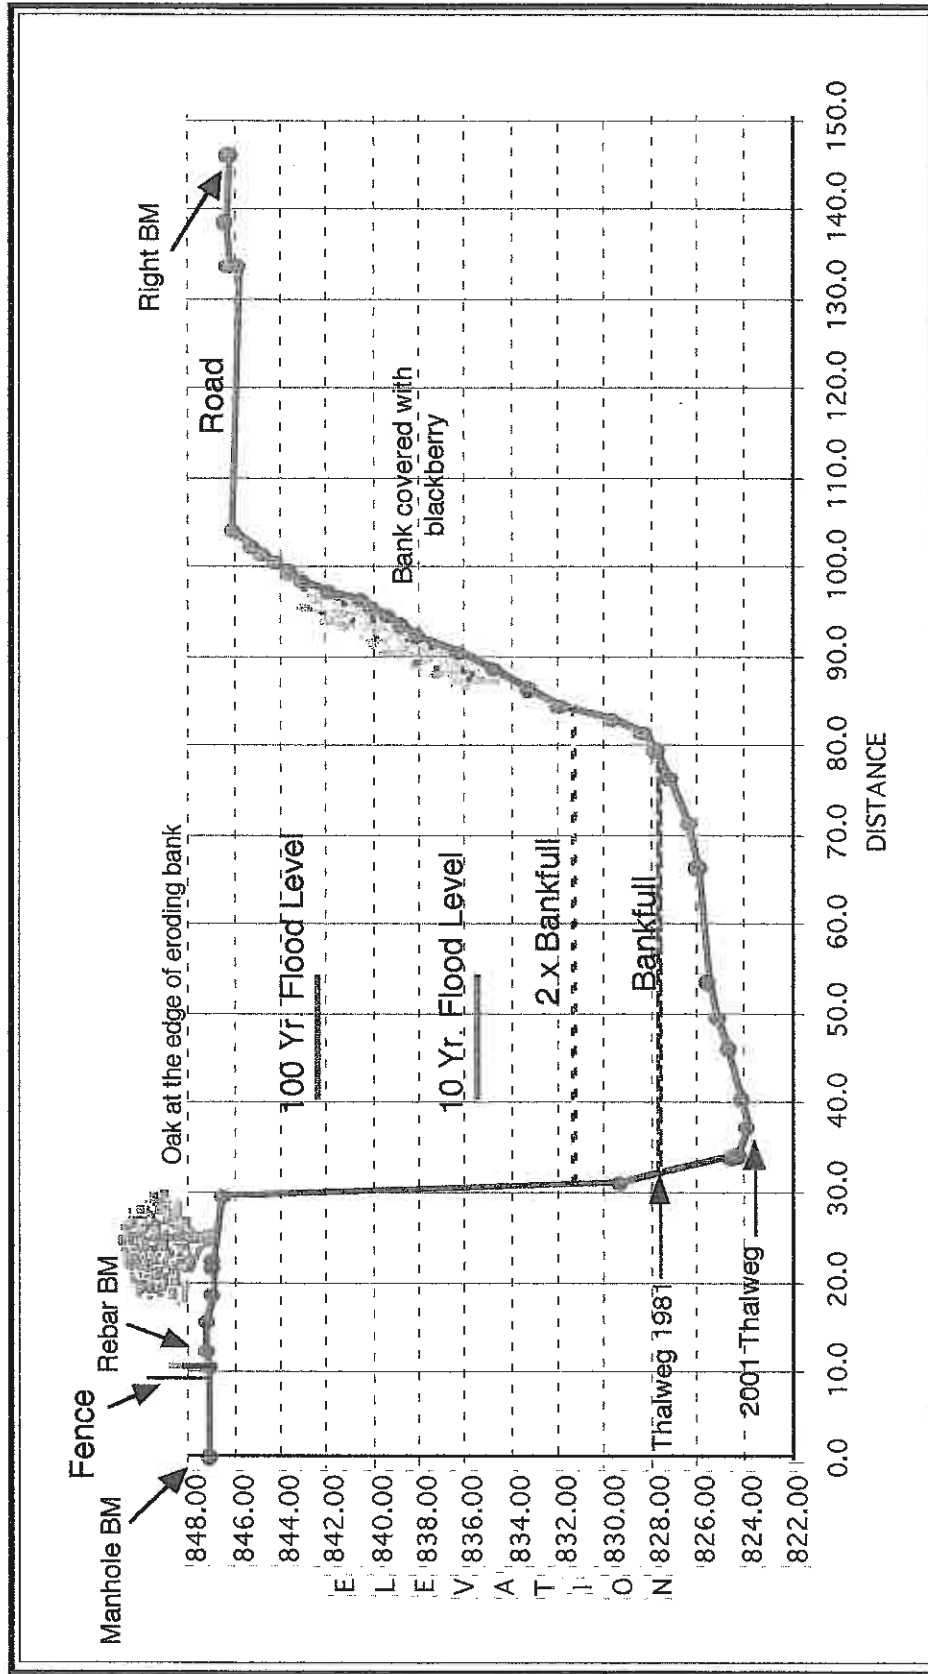
Distance 5,300 ft. from
Salinas R. confluence

At the 5,300 cross-section, the entrenchment ratio is 1.15 to 1. This area of the channel is extremely entrenched and unstable. The entrenched channel causes high stream velocities. The Army Corps estimated velocities of 10.6 feet per second during a 100-year storm and flows of 6,625 cubic feet per second. The left channel bank has eroded horizontally 3.1 feet during the past 12 months. A very large oak tree is being threatened; its roots have been undermined by the erosion. A pool across from the oak tree has filled with sediment during the last year. If the bank is not stabilized soon, the weight of the oak tree will overwhelm the strength of the vertical bank and the tree will collapse into the channel, taking with it an estimated 30 feet of terrace soil.

The accompanying cross-section for 5,300 indicates that twice-bankfull flows are now 15 feet lower than the adjacent terraces, which greatly increases the likelihood for channel erosion. Then, as the channel erodes, it becomes even more entrenched, further increasing the rate of erosion. The condition is exacerbated by construction of streets, parking lots and buildings in close proximity to
